Conserving War Memorials

Case Study: Differential Movement of Foundations

Civilian Second World War Memorial,
Abney Park Cemetery, Stoke Newington, London

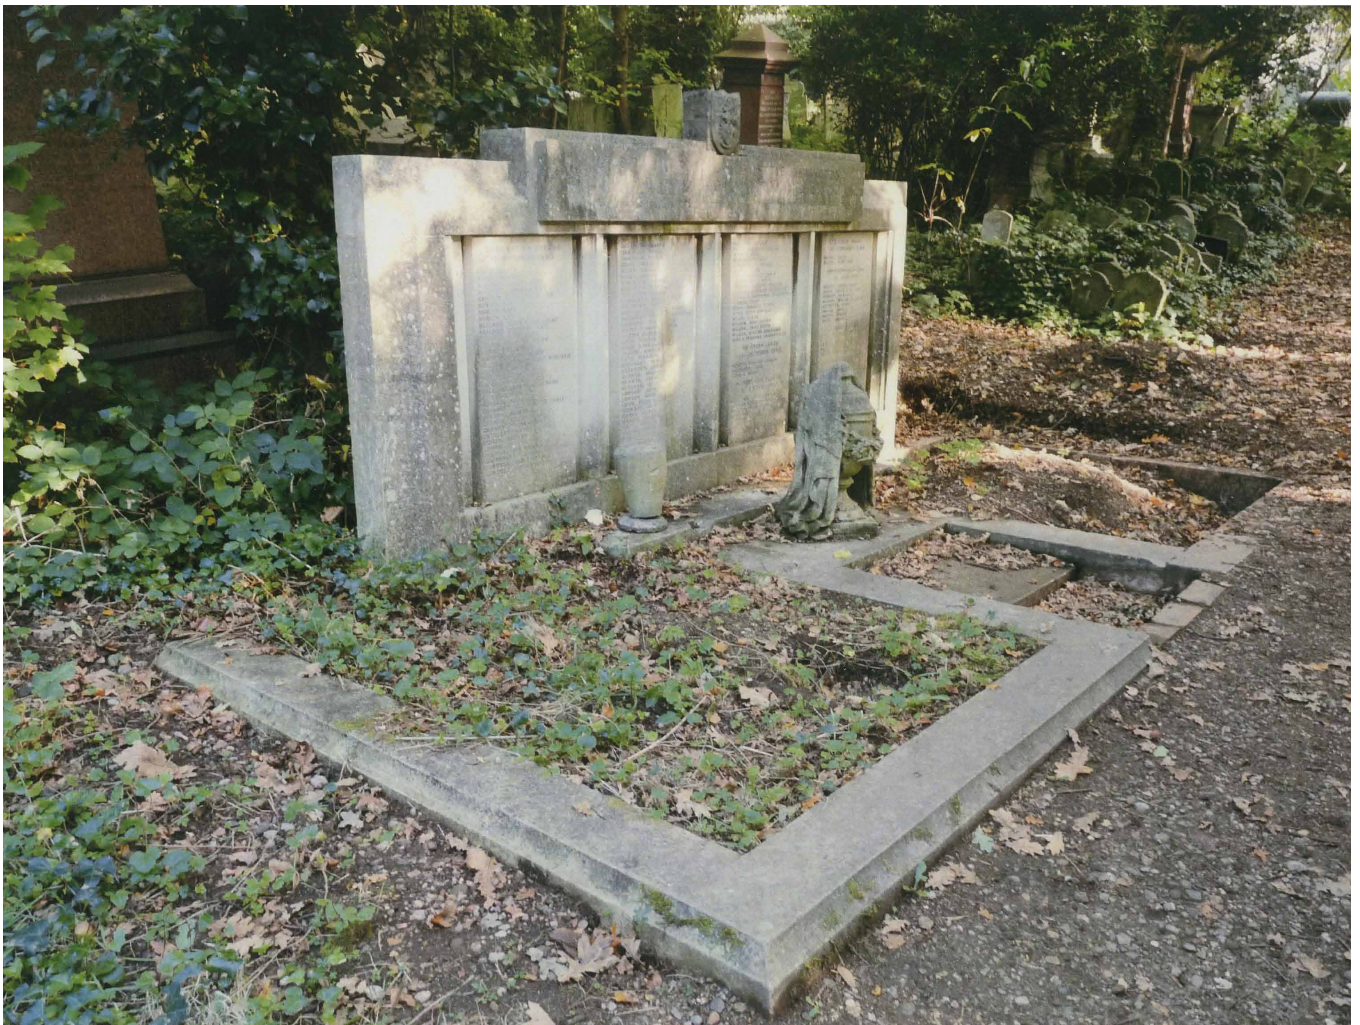
Front cover:

Civilian War Memorial, Abney Park, Stoke Newington, London. The base of the memorial had become unlevel and the panels bearing the names had developed a lean. ©C Loewe

In 2013, the structural engineers survey found the memorial had moved. It was found to have shifted uniformly on its base across its diagonal with a net variation in level of approximately 250mm. The monument was leaning back by an angle of approximately 5° from vertical. Although located in a cemetery, it was understood that there were no burials beneath the monument.

The shift was identified as being due to the differential movement of the foundations. The underlying clay subsoil undergoes seasonal shrinkage and swelling which was made worse by the proximity of the trees surrounding the memorial.

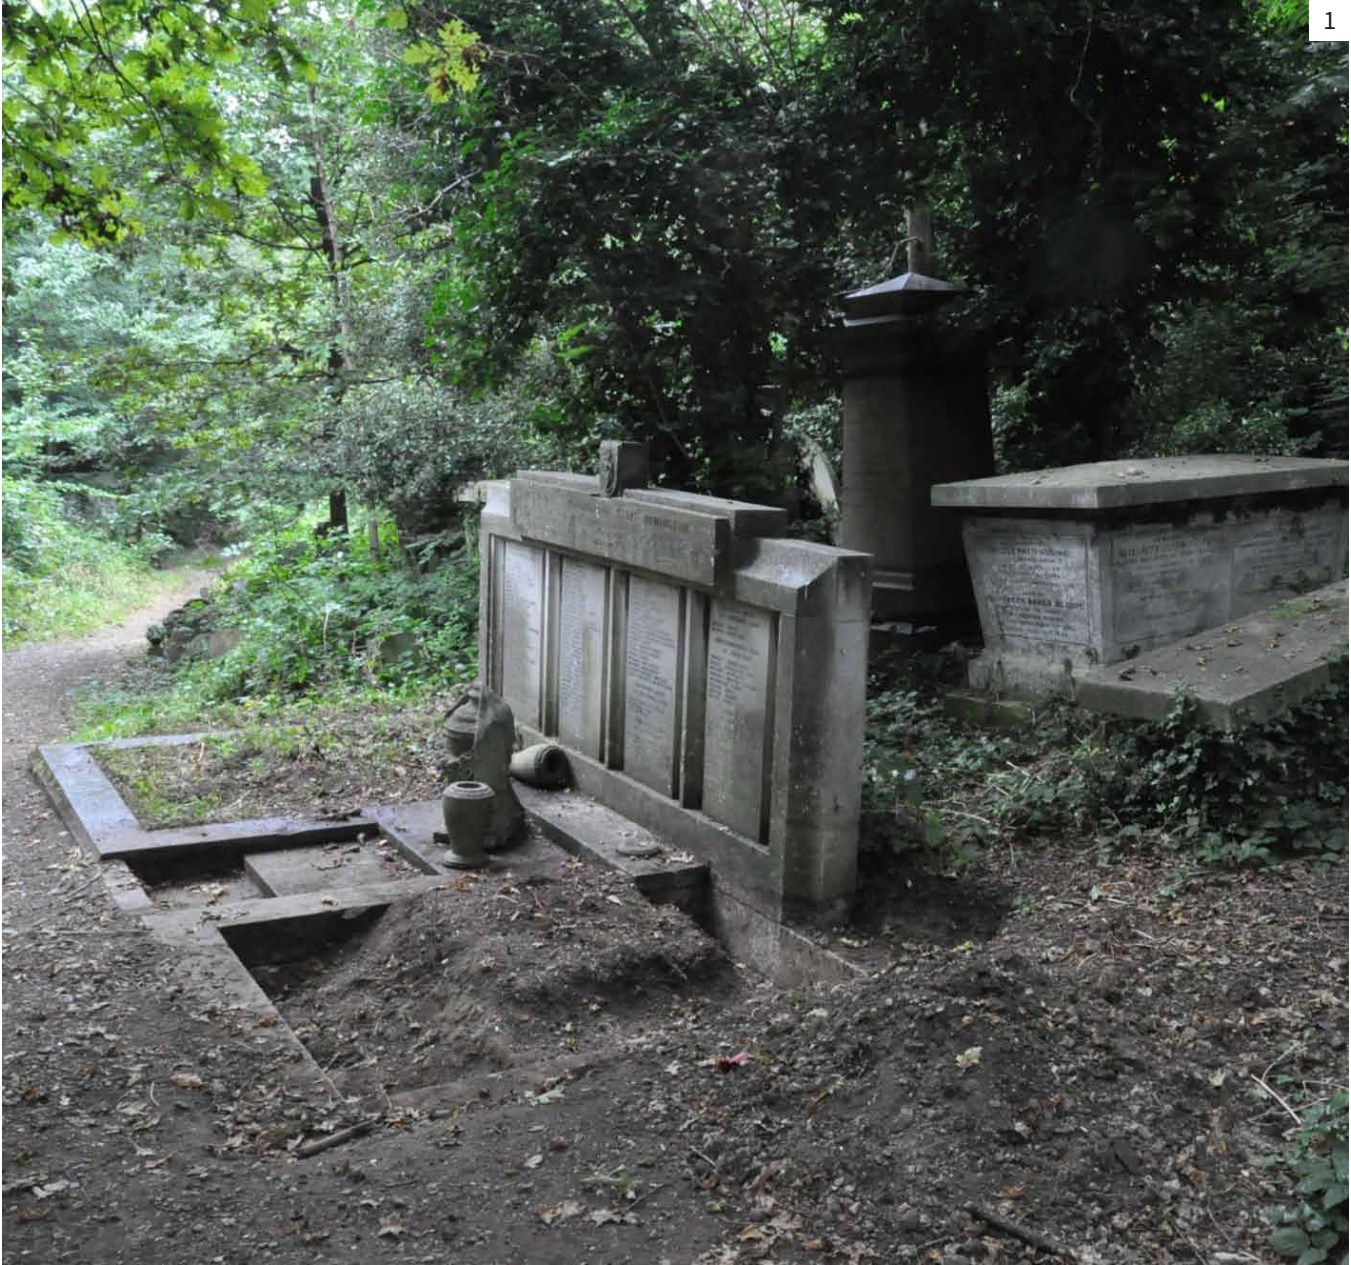
1 The memorial is constructed on clay soil and was closely surrounded by trees and bushes.

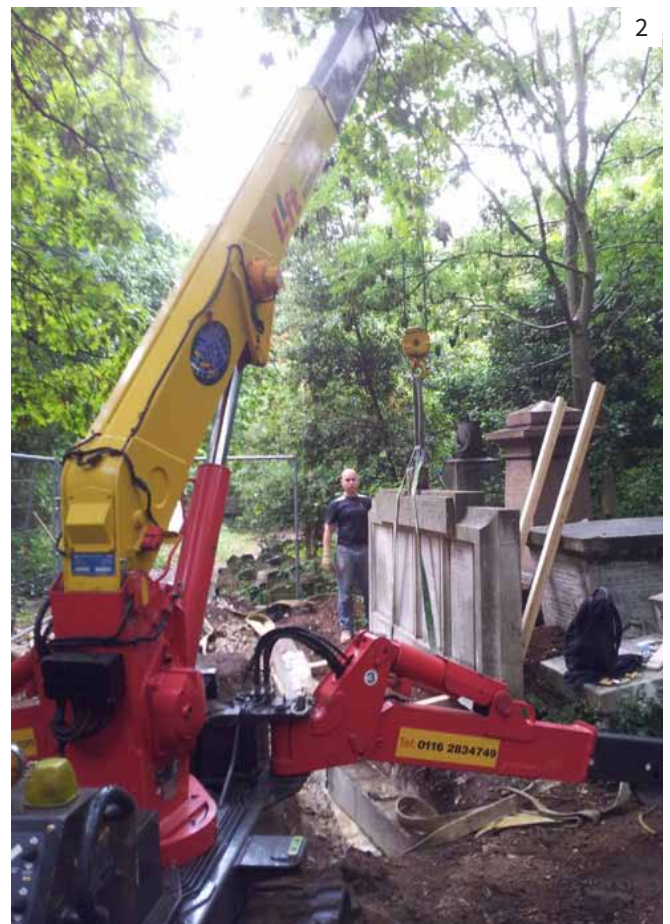
- 2 Lifting the main inscription panel required specialist equipment which could operate in confined spaces.

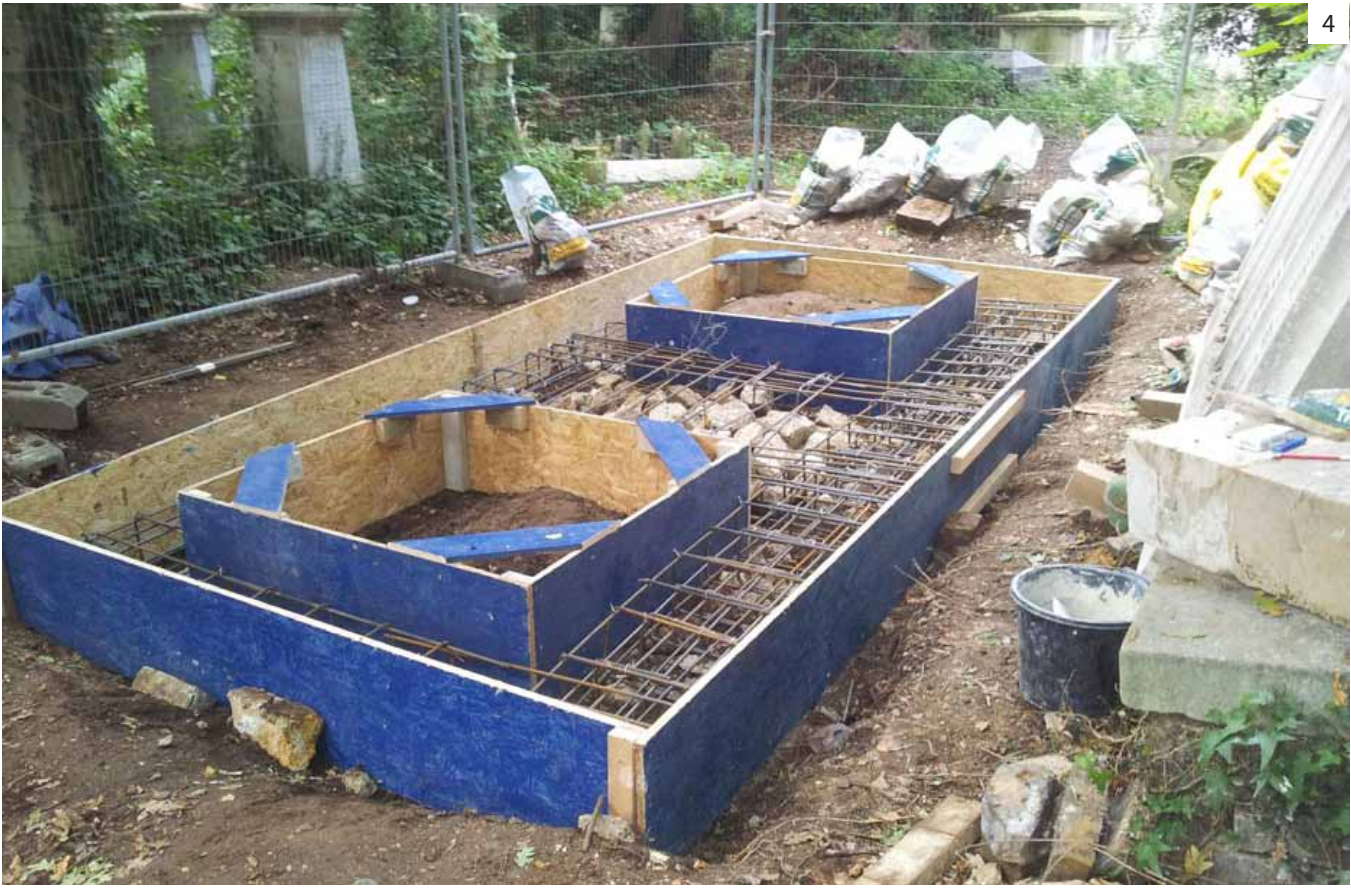
4 Shuttering and steel reinforcement ready to receive the concrete.

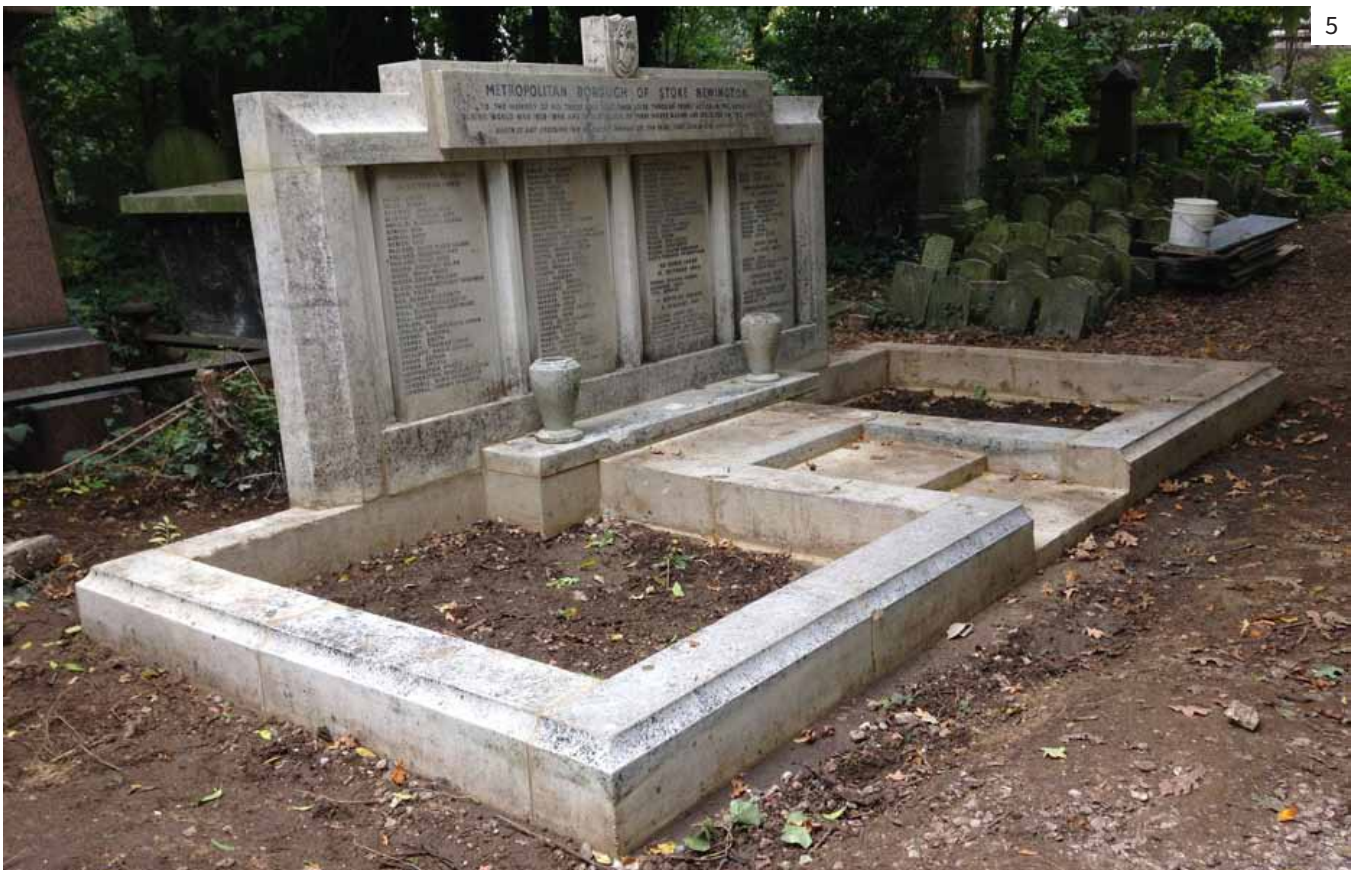
5 The war memorial after structural work was completed.
