Conserving War Memorials

Case Study: The Surface Treatment of Bronze Statuary

First and Second World Wars Memorial,
Bootle, Merseyside

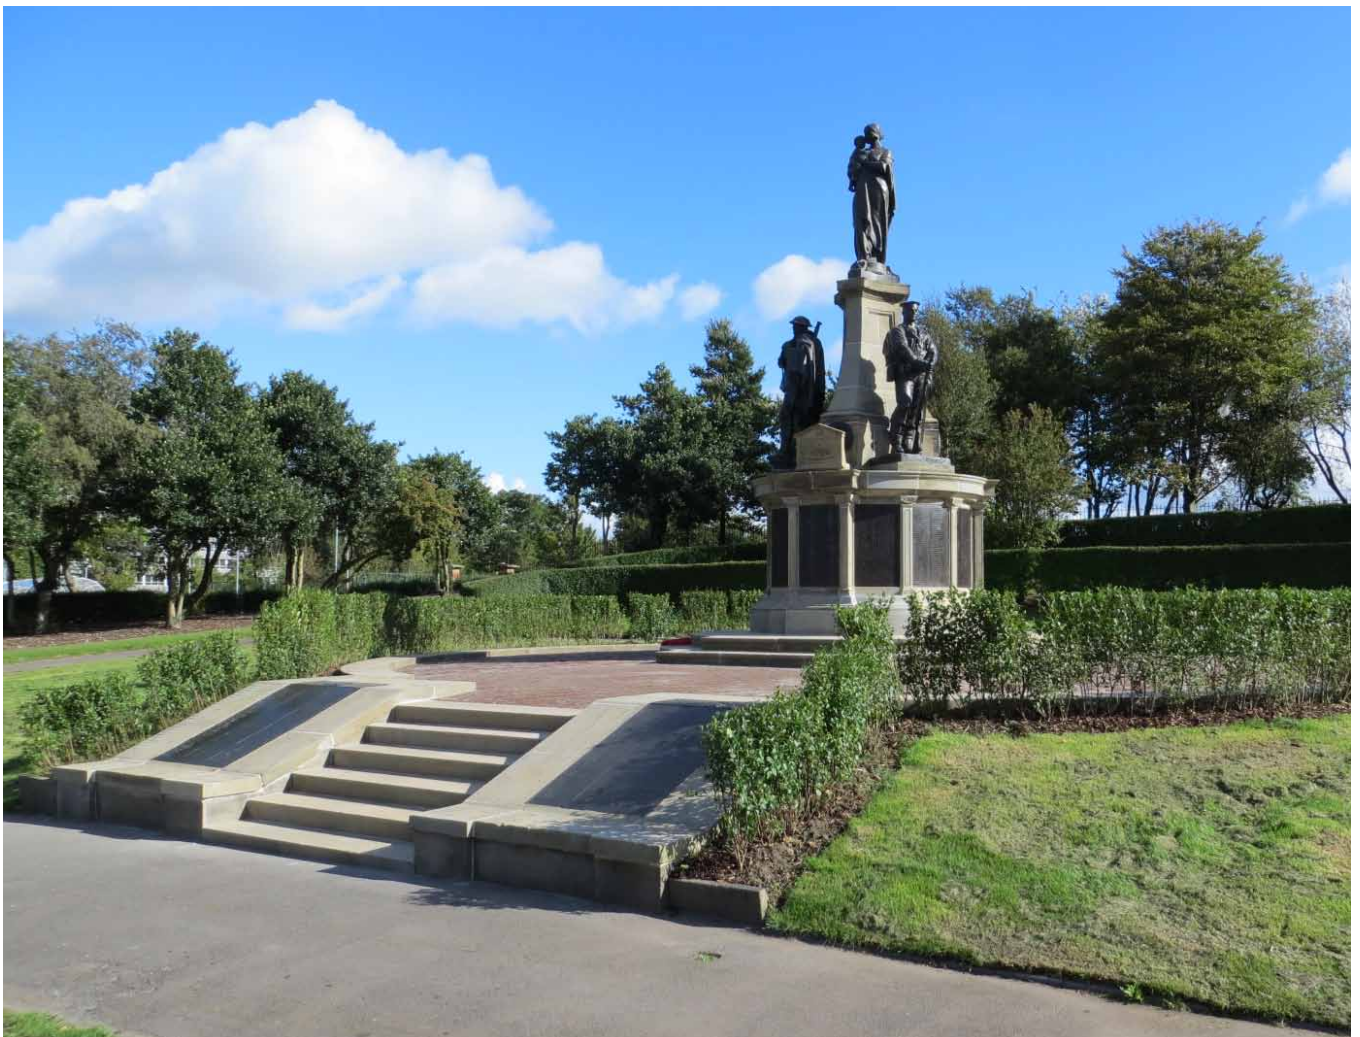
Front cover:

General view of the memorial after conservation work.

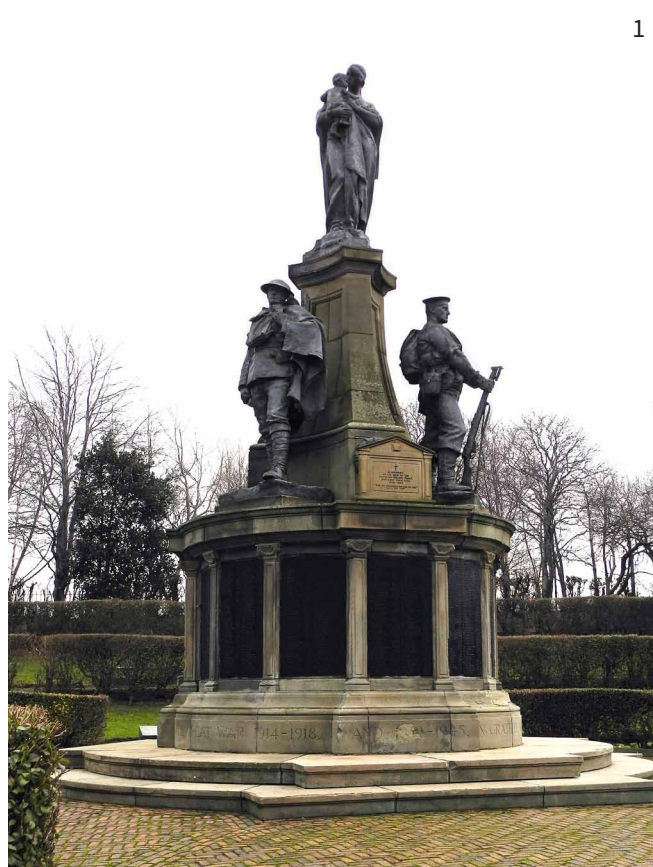
1 The Bootle War Memorial, before conservation.

The Bootle war memorial bronzes had not been regularly maintained and so, over time, green patina had accumulated over parts of the surface of the bronze figures, wreaths and plaques. At some point in the past, the bronzes had been painted with a black, semi-gloss paint to cover the green surface. Weathering had degraded this paint significantly, and in some areas had been lost completely, revealing the naturally formed green patina beneath. However, areas of minor 'active' corrosion were found in recessed areas of these bronzes, which needed to be addressed.

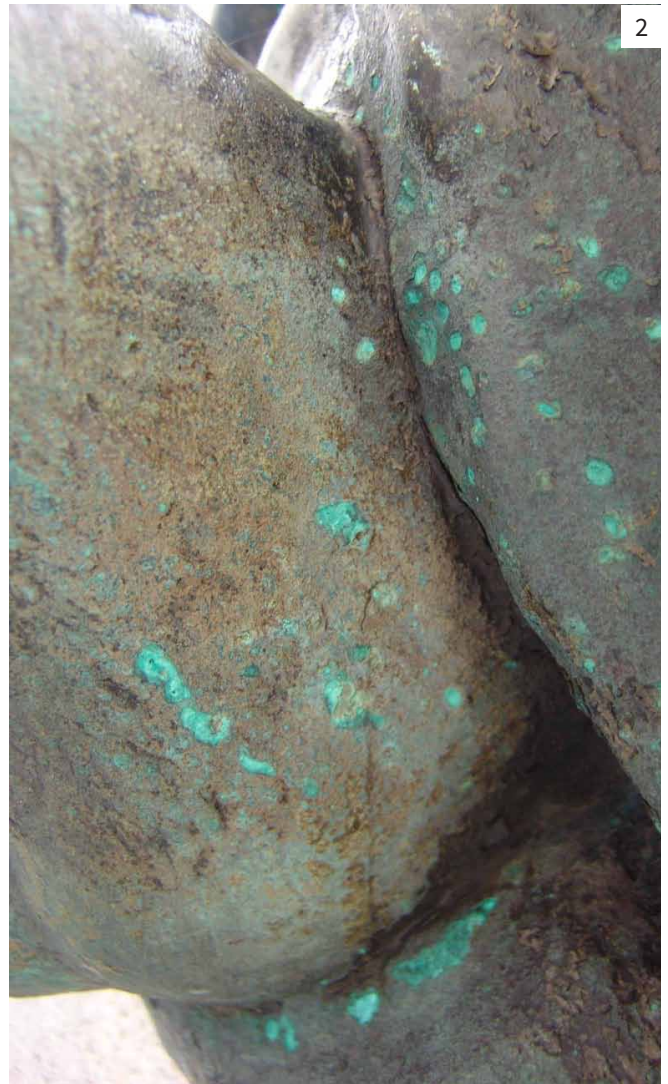
-
- 2 Active corrosion spots on the bronze surface.
 - 3 The bronze surface showing remains of black paint over naturally formed patina.

Removal of the black paint coating was achieved by steam cleaning, with the addition of a proprietary water-based paint remover where required.

Selective, localised glass-bead abrasion or chemical cleaning would be permitted where there was active corrosion, as this must be completely removed to prevent further loss of original material. However, such techniques were not required, as the active corrosion was successfully removed by the steam cleaning.

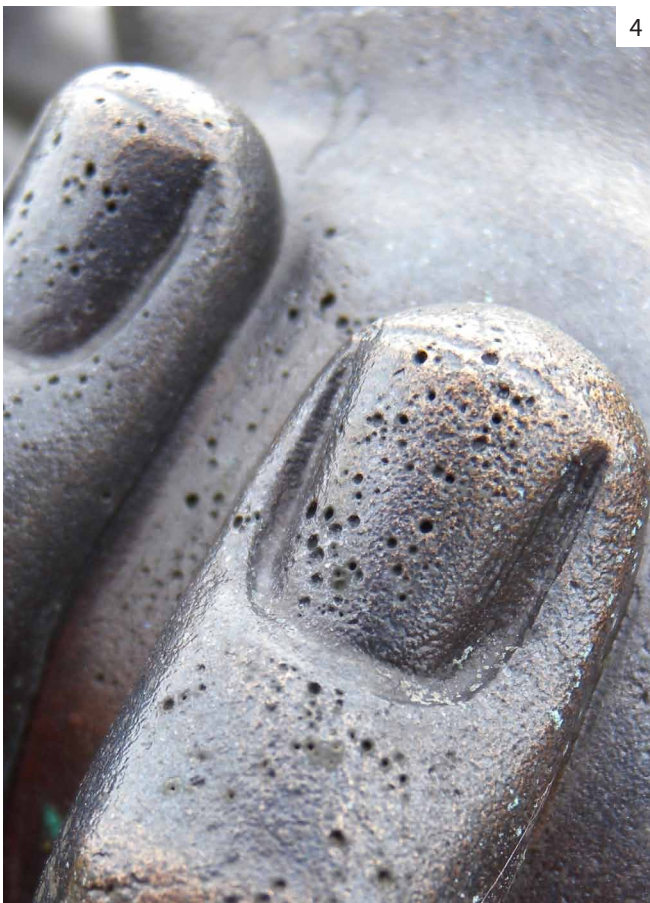
In addition to the deteriorated surface of the bronzes, the overall quality of the casting was poor. Firstly, many parts of the casting were affected by gas porosity (Figure 4): this appears as small pin-holes, or larger, irregularly shaped holes in the surface, caused by trapped air or gas from the metal or mould. Secondly, some areas had been short poured: this occurs when insufficient bronze has been poured into the mould, resulting in a hole or fissure (Figure 5). Such areas are repaired before the sculpture leaves the foundry. This is usually achieved by the insertion of bronze patches, as in this case, although a large hole in the top of the Infantryman's helmet had been filled with cement. Casting faults, and failed or poorly executed foundry repairs, often trap pollutants and moisture and consequently can initiate corrosion. These need to be carefully identified by the conservator, and made good.

-
- 4 Gas porosity in the surface of bronze.
 - 5 An example of 'short pour'; its foundry repair has now failed and is lost.

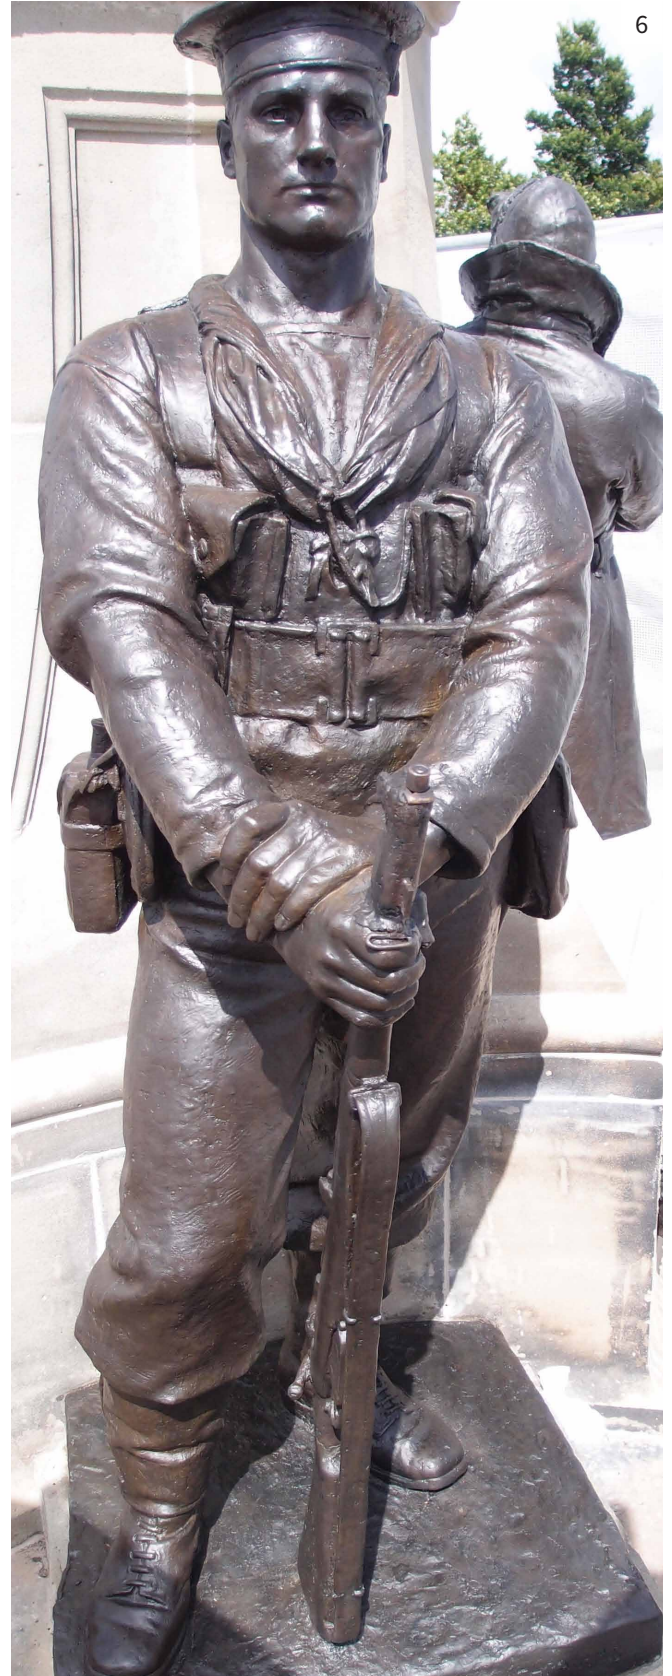
6 The surface of the bronze after patination treatment and waxing.

Before patination of the bronzes, a small test area of patination was prepared and then waxed, so that the custodian could approve the intended final appearance of the surface of the bronzes. The existing naturally patinated surface of the bronzes and the unpatinated, raw metal surfaces were then both corrected overall, by the application of a traditional chemical patina over the existing green patina and over the areas of bright metal that had been stripped of their original patina in past treatments. This returned the colour of the bronzes to a mid- to dark brown, while still retaining traces of dark green: the surface was thus visually unified but exhibited a subtle variation of colour reflecting the memorial's age.

The application of protective coatings of clear, microcrystalline wax has resulted in a cared-for appearance while still respecting its original appearance and condition history. Furthermore, this treatment has placed the bronze into a stable, maintainable condition, which ensures that it can retain its good condition at optimal cost effectiveness to the custodian responsible for its care.
