# Heritage at **Risk**

Historic England

**North East Register 2016**

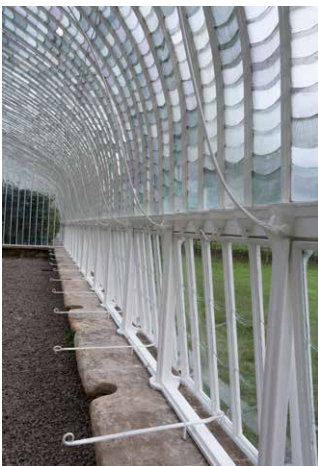
## Felton Park Greenhouse Felton, Northumberland

The glasshouse at Felton Park was erected around 1830 to designs attributed to John Claudius Loudon. It measures 90 x 30 feet and stands against an 18th-century brick garden wall that is over 13 feet high. The slender, curved roof, of wrought iron glazing bars with delicate panes of fish-scale glass, rests elegantly

on a dressed stone plinth. The structure represents an important example of 19th-century architectural engineering, created at a time when estate owners were developing their gardens by introducing exotic plants from abroad. Although many glasshouses were built for horticultural purposes in the 19th century, few have survived and the curvilinear example at Felton is one of only twenty to survive in England.

Following decades of neglect, the glasshouse had been on the Heritage at Risk Register since 1998. The good news is that an extensive repair programme (managed by Spence & Dower architects and funded by the owner, Northumberland County Council, Historic England, the Heritage Lottery Fund and the Country Houses Foundation) has resulted in the building being removed from the Register. The repair project showcased the wide range of specialist craft skills involved in repairing and conserving historic metal and glass. It won a commendation at the Georgian Group Architectural Awards in 2015 and a certificate of commendation at the Historic England Angel Awards in 2016. Work has also begun on introducing new plants and shrubs to join the two surviving camellias and large vine.

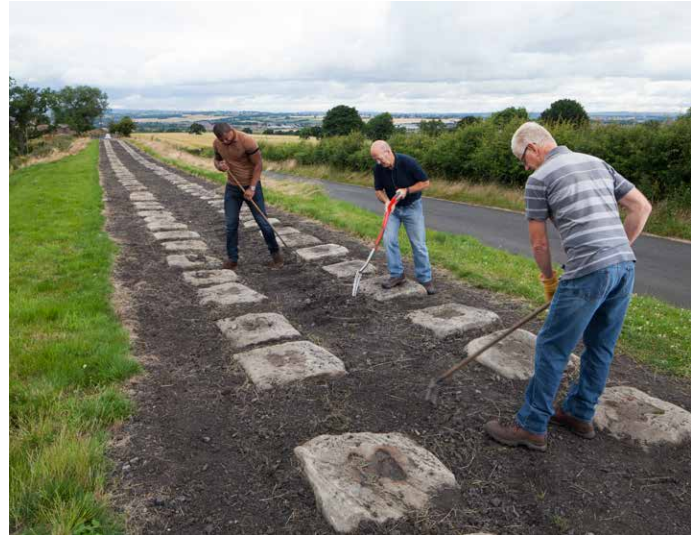
An example of what can be done is the work achieved by the Brusselton Incline Group (see image), established

specifically to promote and preserve the stretch of the railway running from Brusselton to West Auckland (visit [www.brusseltoninclinegroup.webs.com](http://www.brusseltoninclinegroup.webs.com) for more information). 2025 will see the bicentenary of the railway, giving Historic England and partners a target date by which to resolve the issues affecting the monument.
