Heritage at **Risk**

Historic England

East Midlands Register 2017

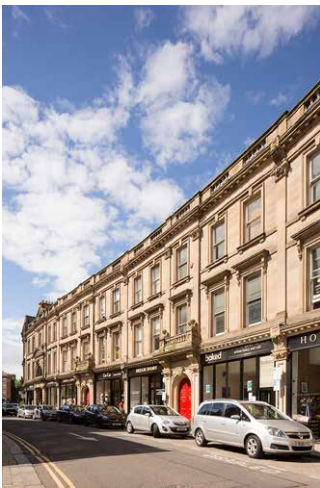
City Centre Conservation Area **City of Derby**

Derby City Centre Conservation Area is finally off the Heritage at Risk Register this year, following an eight-year programme of Historic England grant aid partnered by Derby City Council and business owners.

But the project achieved much more than simply improving the condition of individual historic buildings. It reversed the decline of traditional retail areas, increased footfall and business occupancy, encouraged new investment, and restored pride and confidence in Derby's historic core as a hub of economic success and well-being.

Historic England's Derby PSiCA (Partnership Scheme in Conservation Areas) complemented other initiatives by seeking to restore the identity and attractiveness of key streets such as The Strand, Sadler Gate and Wardwick. The scheme targeted the repair and reinstatement of historic shop fronts, removing the clutter of unsympathetic signage, and highlighting characterful historic architectural details and materials.

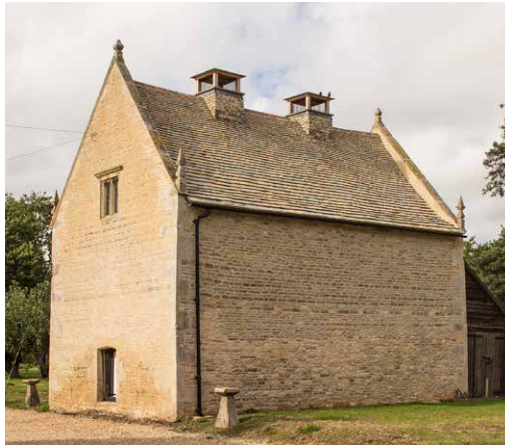
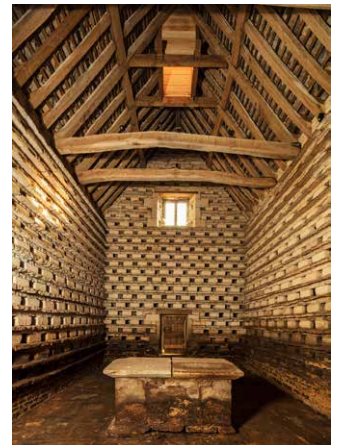
Historic England grant-aided repair of the dovecote at Barholm Old Hall rescued a special piece of Lincolnshire heritage and helped re-discover lost craft skills.

The building is believed to date from the 17th century and unlike many dovecotes, it had survived into the 21st century in a remarkably complete and unaltered form. However, its stone slate roof covering was failing and penetrating rainwater had weakened its walls. The problem had become so severe that stone-filled gabions had to be installed temporarily to prevent collapse.

The repair of the dovecote benefitted from a new supply of Collyweston roof slates. Mined Collyweston stone historically required exposure to winter freezes in order to split to the correct thickness. The slating industry had all but died out as modern winters failed to deliver sufficiently cold conditions. Now the distinctive Collyweston slates, so important to the region's character, are available in quantity again thanks to

the commercial application of an artificial freeze-thaw process developed in partnership with Historic England.

The repair project provided an opportunity to revive another traditional skill almost lost from the East Midlands. Training sessions by an earth construction specialist ensured sympathetic repairs at Barholm and will help to ensure successful future conservation of earth mortared buildings across the region.

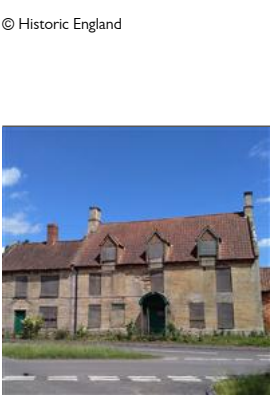
<p>SITE NAME: Somerton Castle and outbuildings, Castle Lane, Boothby Graffoe</p> <p>DESIGNATION: Scheduled Monument and Listed Buildings - 2 grade I, LB grade I</p> <p>CONDITION: Fair</p> <p>OCCUPANCY: Vacant/not in use</p> <p>PRIORITY CATEGORY: F (F)</p> <p>OWNER TYPE: Private</p> <p>LIST ENTRY NUMBER: 1005015 and 1360511; 1061975</p>	<p>Early C14 castle with C17 farmhouse and later outbuildings. The extensive property had fallen into disrepair and the farm buildings were largely redundant. A new owner is undertaking a major repair and conversion project. This has been informed by thorough surveys and archaeological investigations, and advised by the Local Planning Authority and Historic England. The repair and refurbishment of the house has been undertaken and the ruined northeast tower has been repaired. Excellent progress is being made towards removing the site from the HAR Register.</p> <p>Contact: Ben Robinson 01604 735460</p>

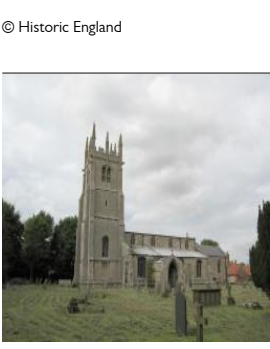
<p>SITE NAME: Parish Church of St Denys, Main Street, Aswarby and Swarby</p> <p>DESIGNATION: Listed Place of Worship grade I, CA</p> <p>CONDITION: Very bad</p> <p>PRIORITY CATEGORY: A (A)</p> <p>OWNER TYPE: Religious organisation</p> <p>LIST ENTRY NUMBER: 1360619</p>	<p>Church of C12 origins with later C14 and C15 work. Restored in 1850 by Edward Blore. The stability of the masonry spire is of concern and the top courses were taken down for safety reasons in 2015. There are numerous open joints which have allowed water to penetrate inside. Roof coverings to the nave and chancel are in need of repair and numerous rainwater goods are defective. There is established vegetation growth in some gutters and hoppers. The church has been offered a Heritage Lottery Fund Grant for Places of Worship grant to tackle the repair work to rainwater goods and the spire.</p> <p>Contact: Penny Evans 01604 735415</p>
