Discovery, Innovation and Science in the Historic Environment

RESEARCH

ISSUE 12 • SCIENCE SPECIAL 2019

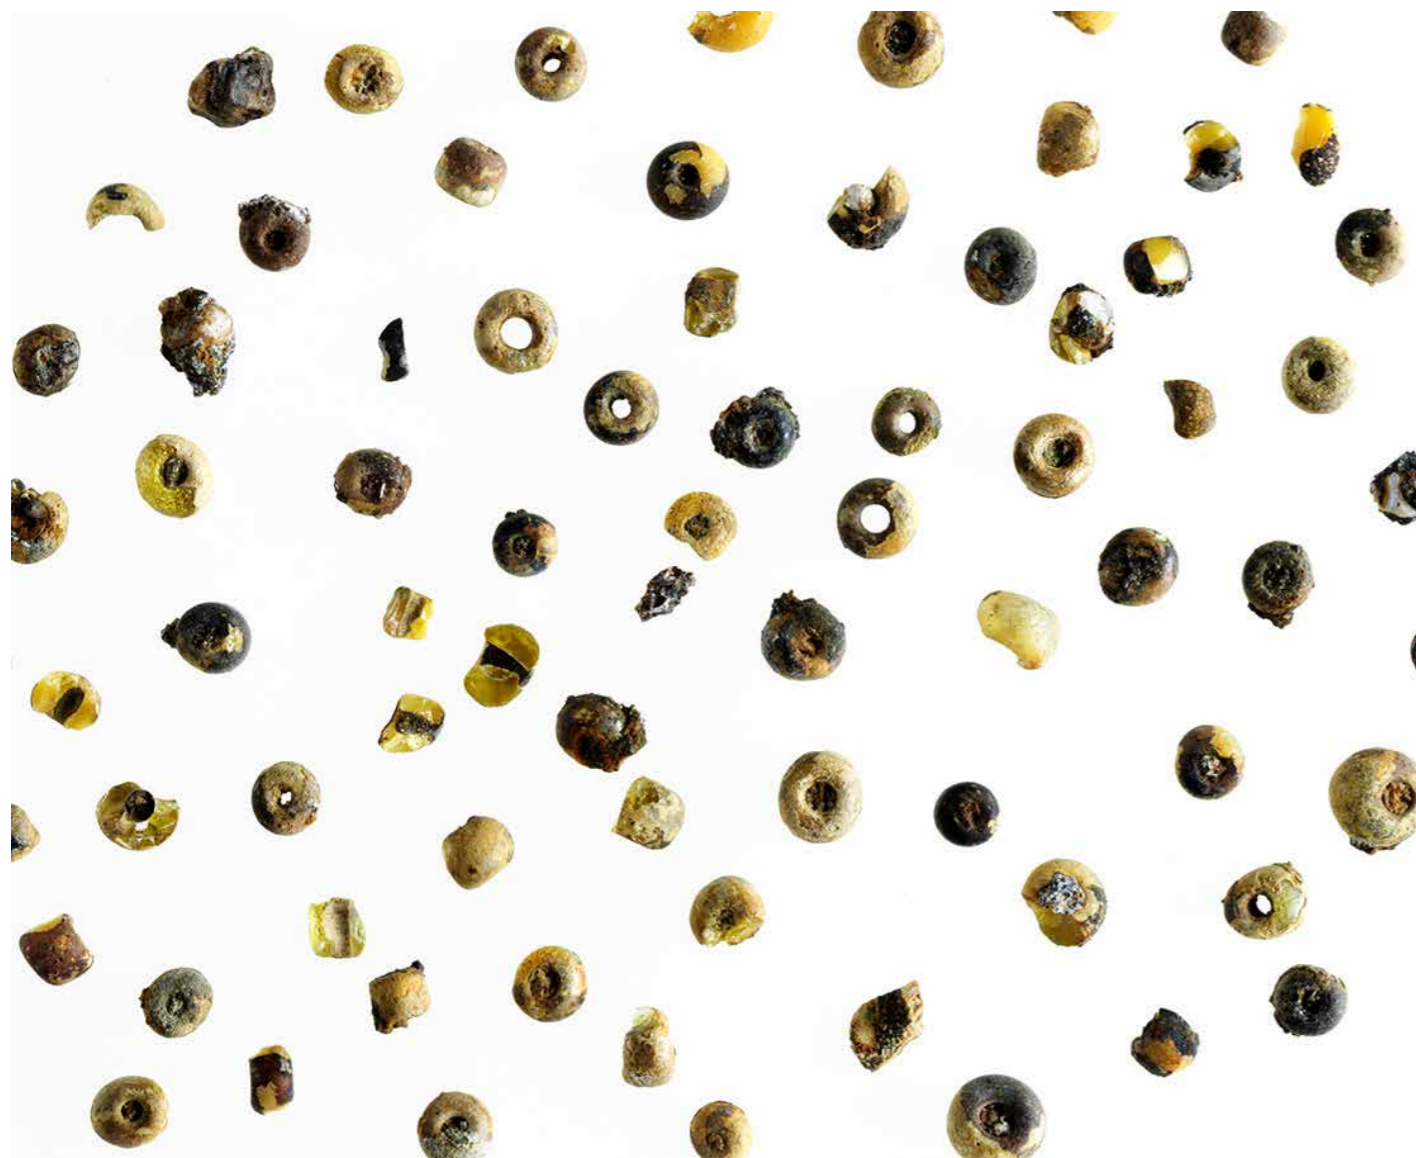
Left: Selection of glass beads micro-excavated from concretion shown in the previous figure. © Rijksdienst voor het Cultureel Erfgoed/Historic England

Below: (A) Glass beads mounted in resin and polished for analysis. (B) Electron microscope image of a white bead, which is made from two layers of white glass (speckled layers) and an outer coating of clear glass. © Rijksdienst voor het Cultureel Erfgoed/Historic England

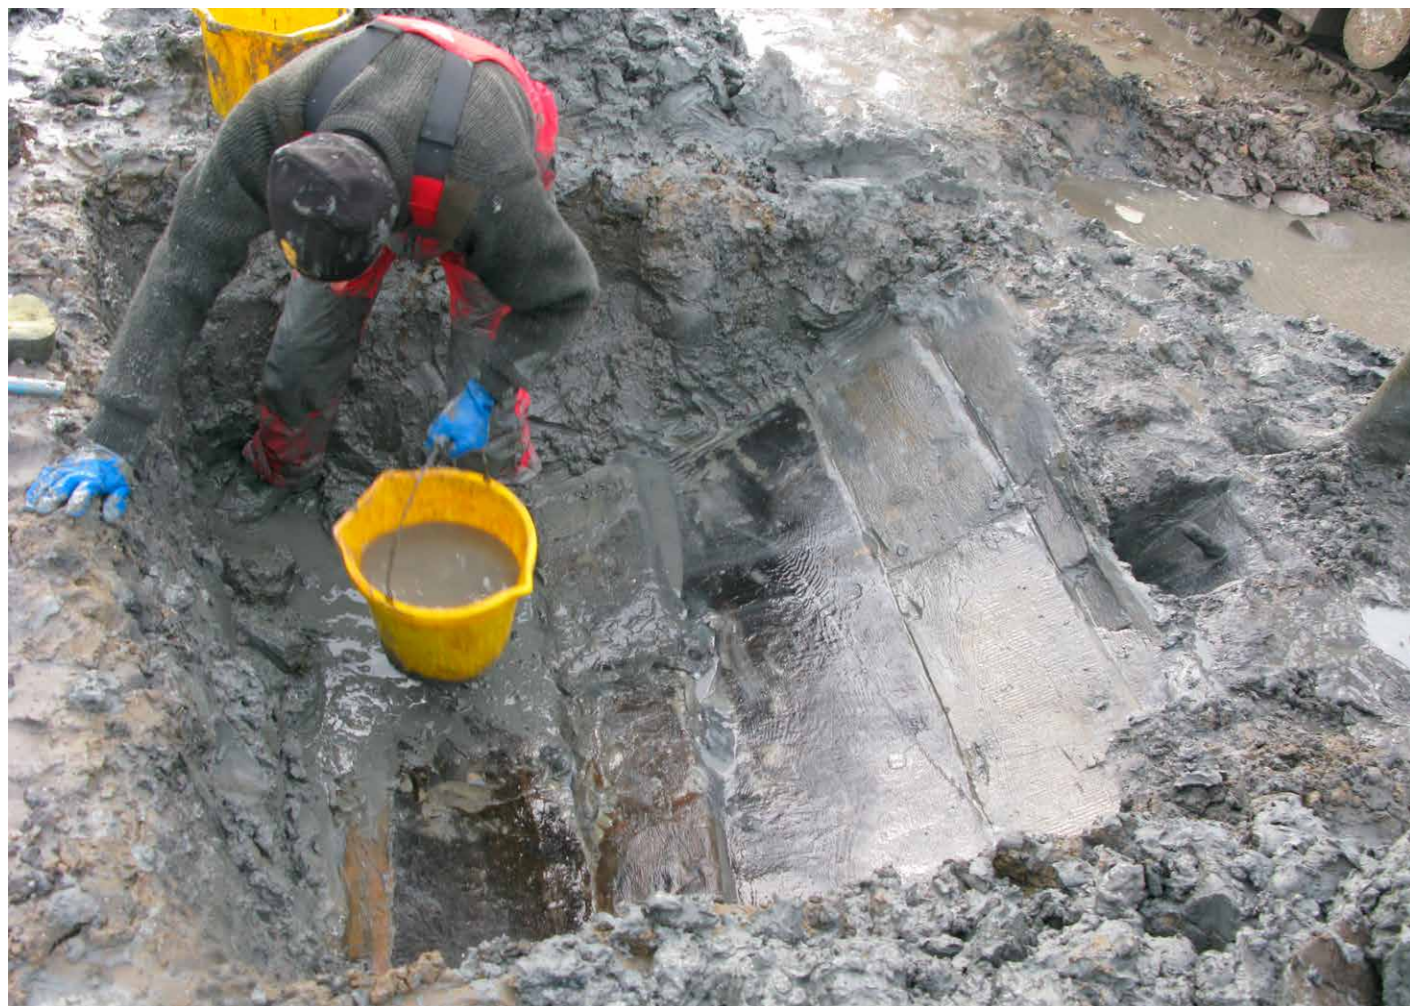
Above left: The excavation of the Tankerton wreck by Wessex Archaeology and Timescapes, funded by Historic England. © Historic England, Rod Bale

Its application to the recently listed inter-tidal wreck at Tankerton beach near Whitstable, Kent, revealed that the dated timbers represented at least two phases of felling and three different woodland sources. A construction date towards the middle of the latter half of the sixteenth century was indicated, with major repairs being undertaken within at most two or three decades. The oak framing timbers and hull planks proved to include timbers of both German and English origin, the German timbers

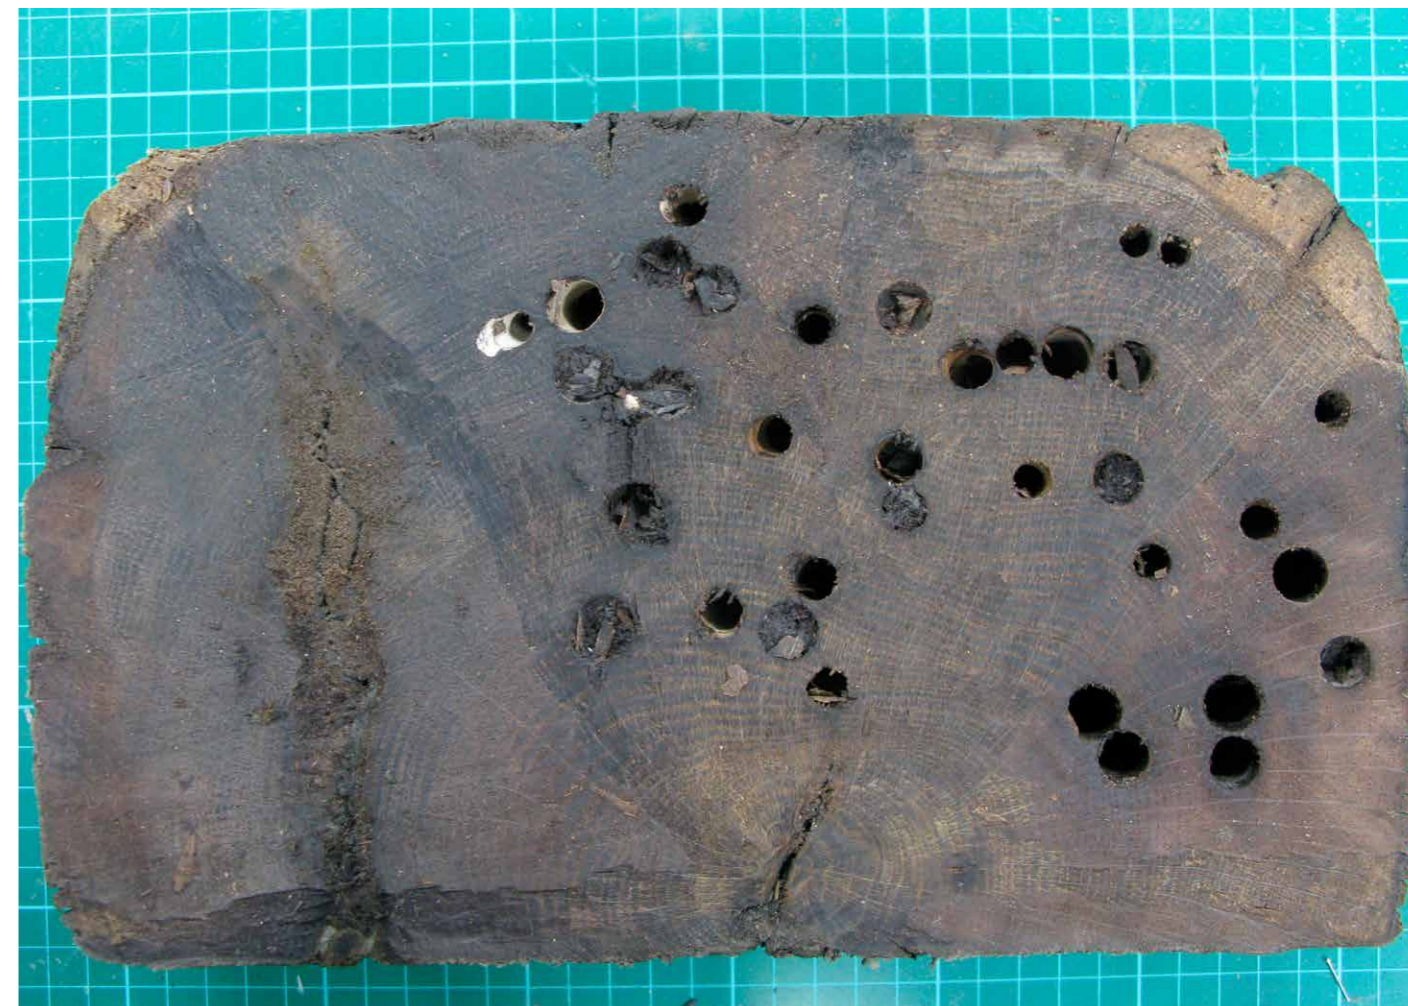
Above right: A cross-sectional sample from an oak framing timber of English woodland origin, showing damage by marine wood borers. © Historic England, Rod Bale

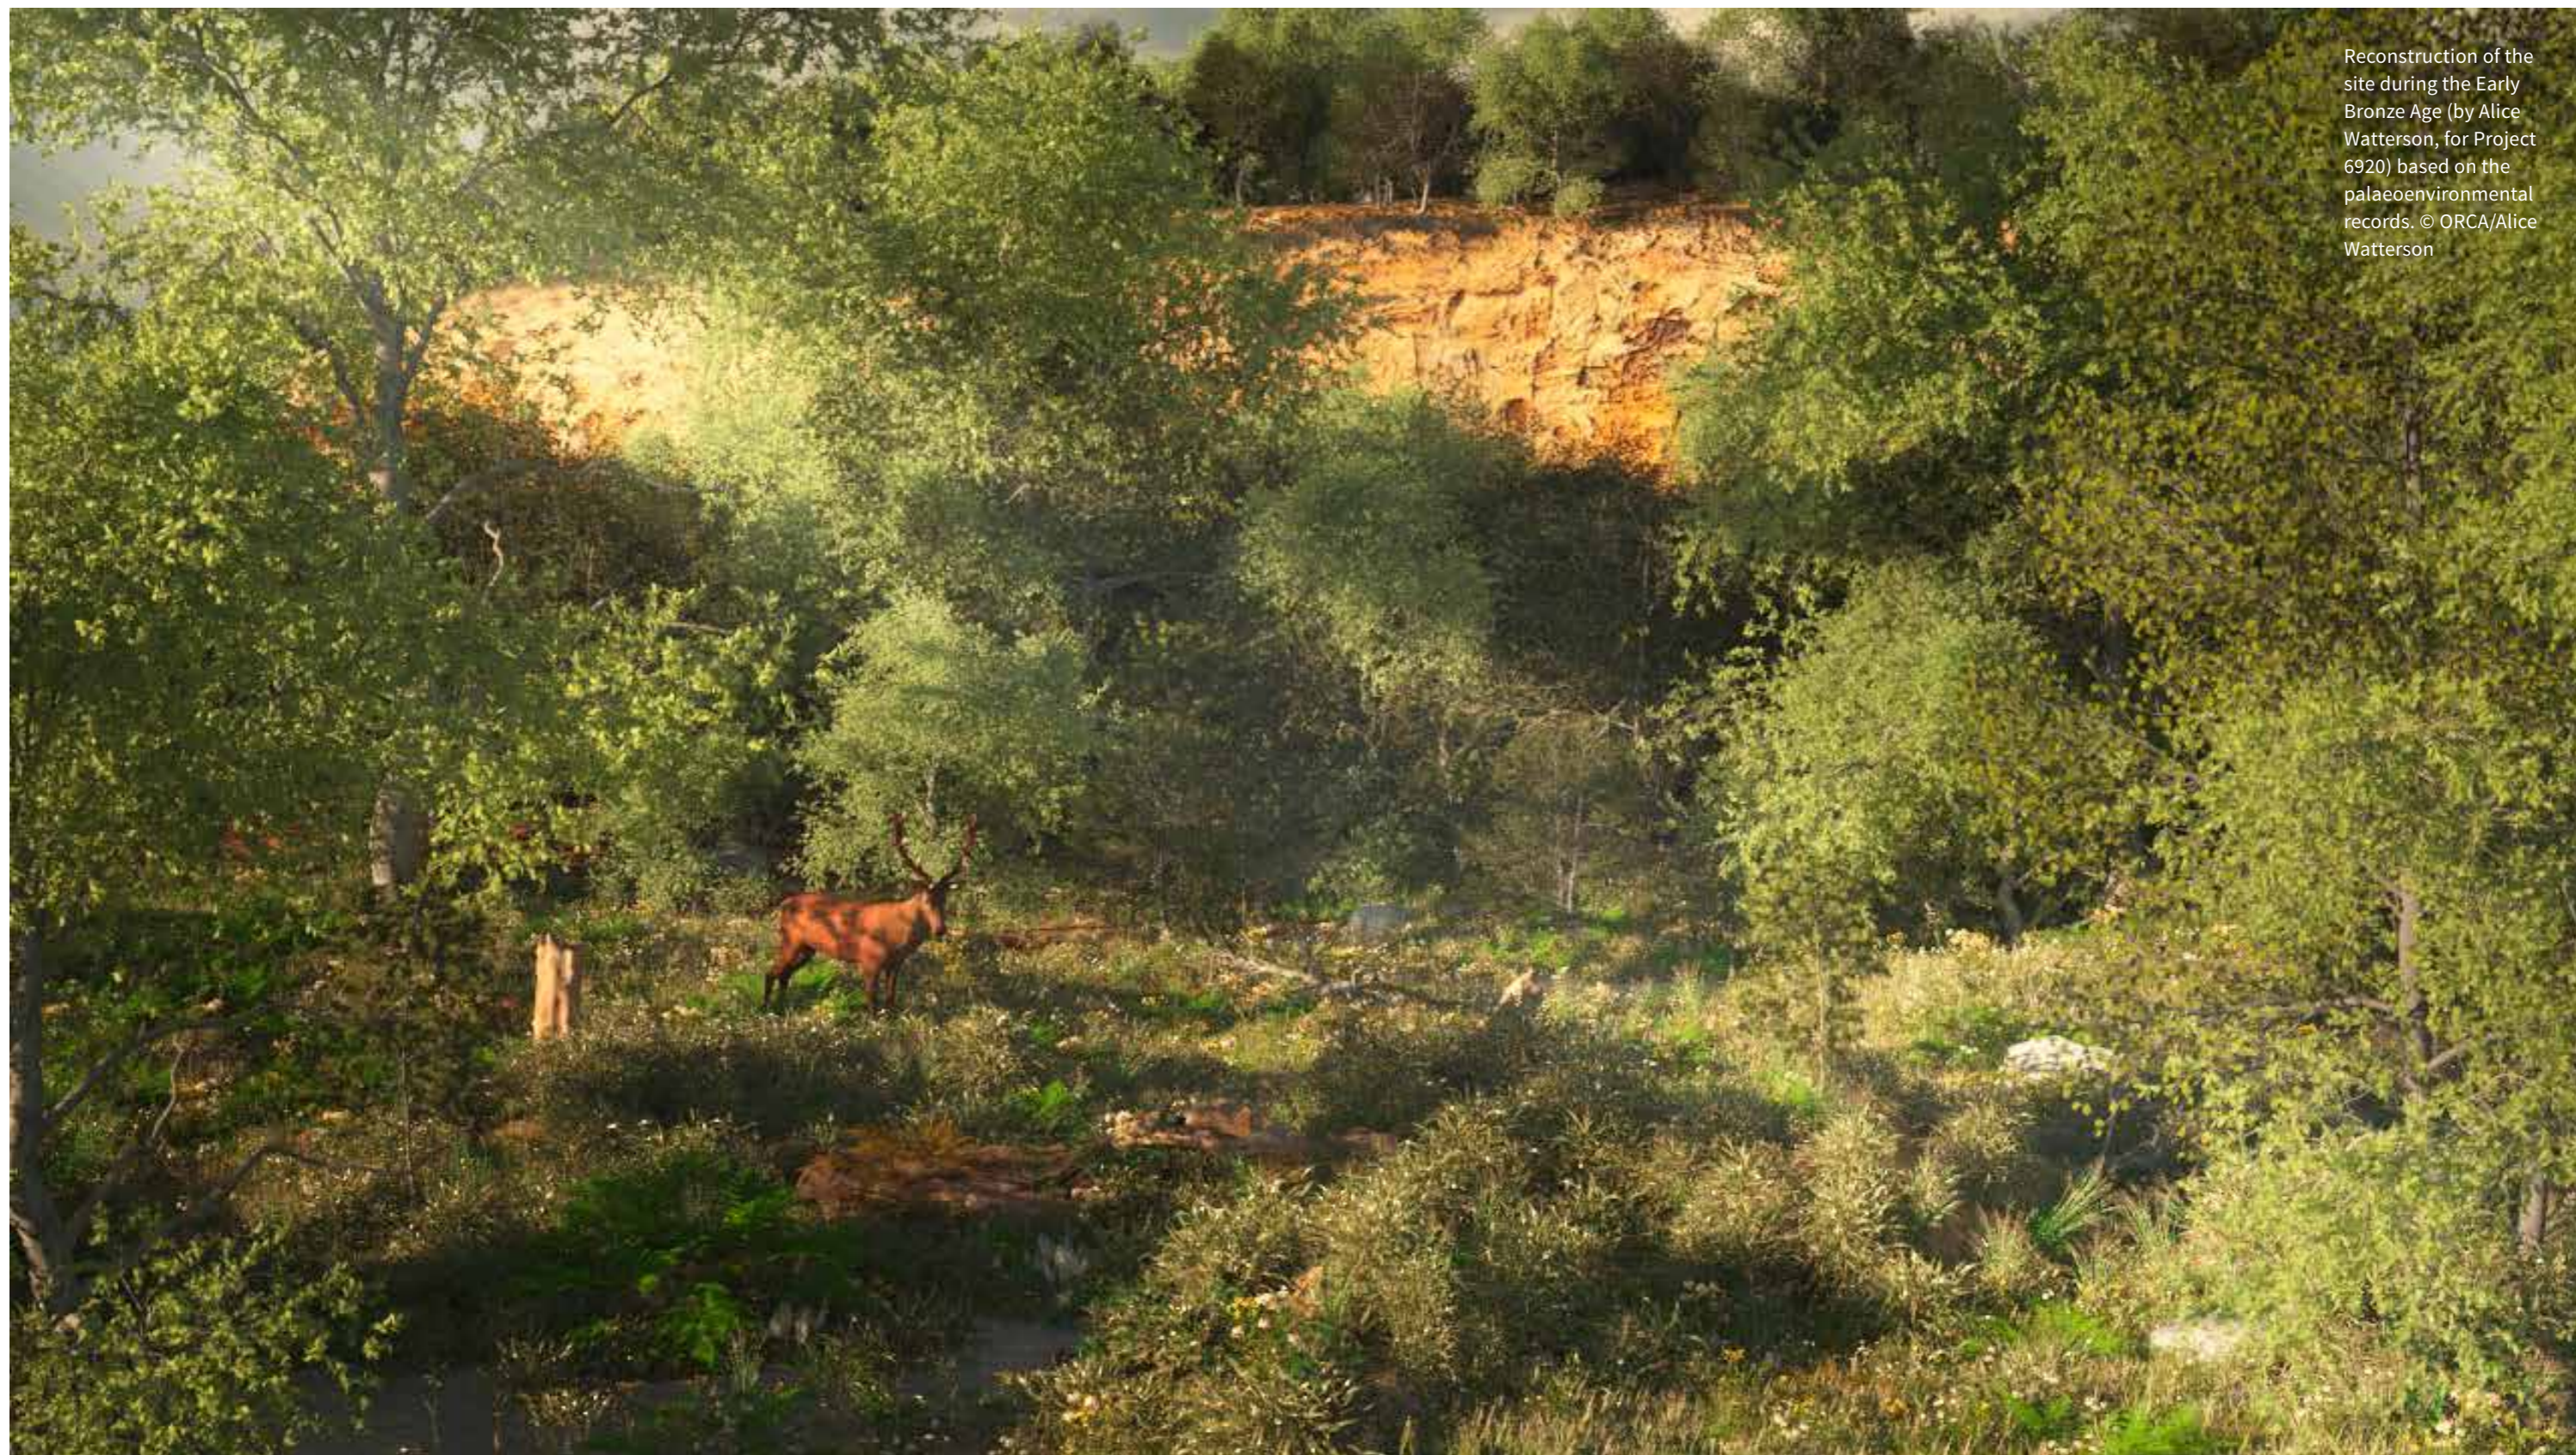
Reconstruction of the site during the Early Bronze Age (by Alice Watterson, for Project 6920) based on the palaeoenvironmental records. © ORCA/Alice Watterson

Putting all of the information together, we have worked with graphic artist Dr Alice Watterson of the University of Dundee to provide an interpretation of how this area of the Pett Level would have looked around 4,000 years ago. >>

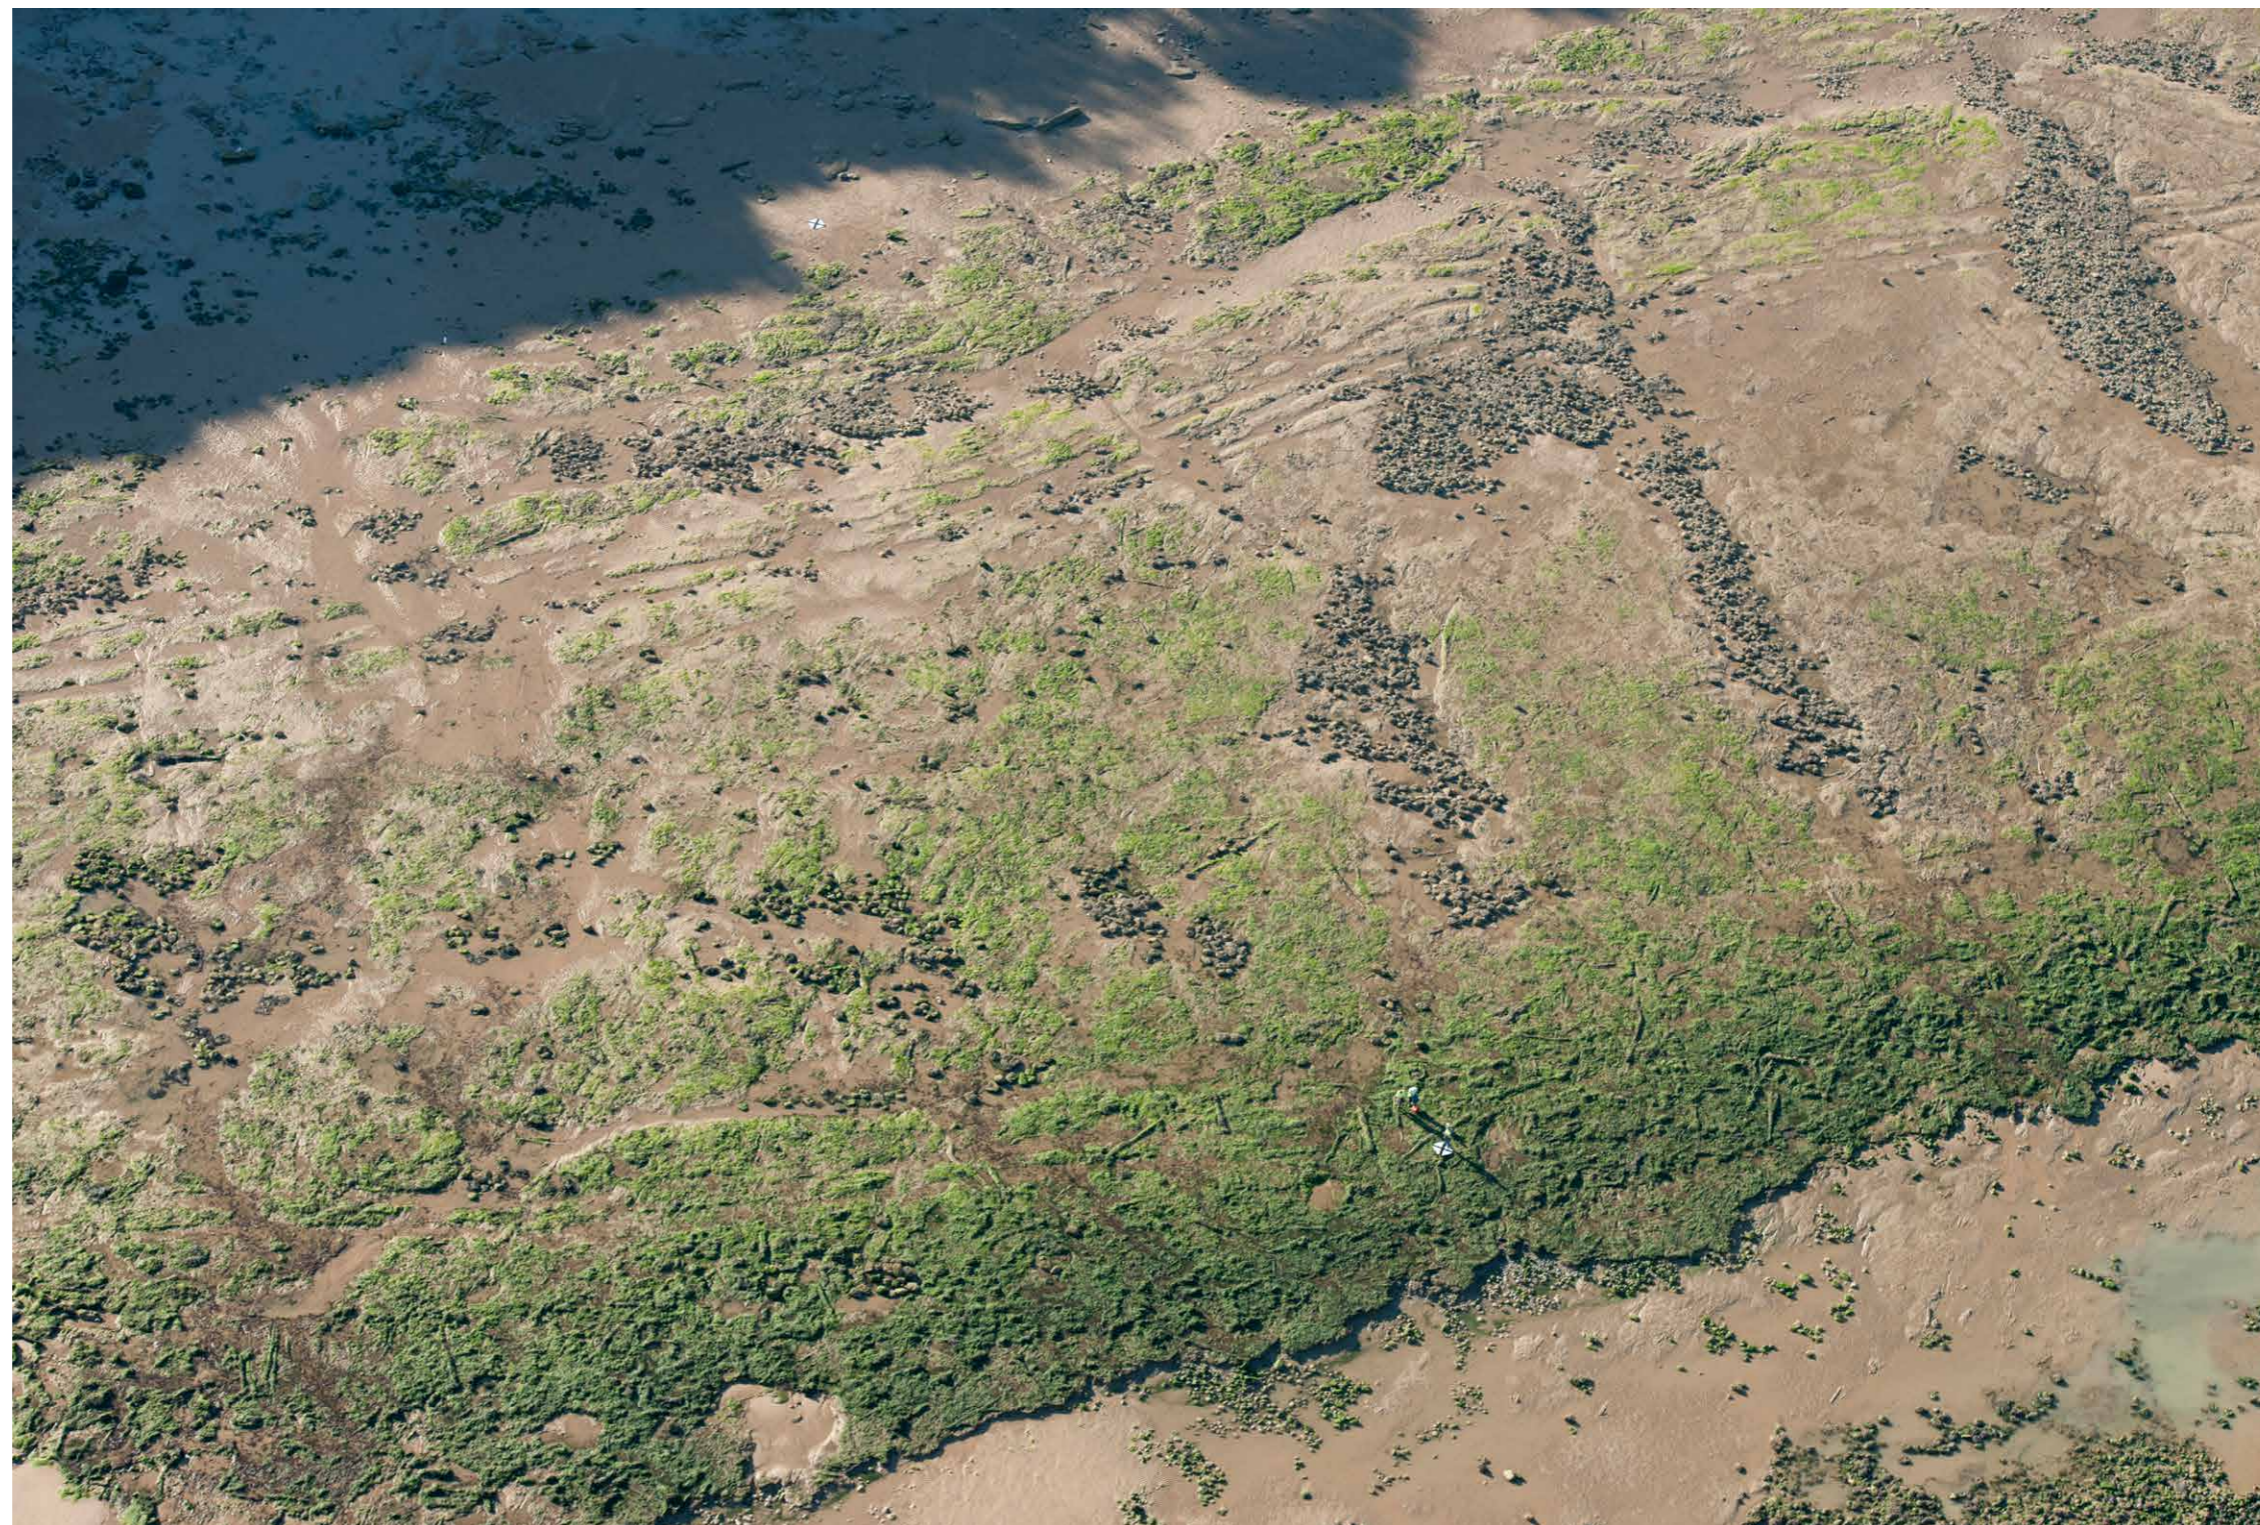
Above: The site during the high-level recording (July 2016), showing one of the black-and-white target boards used to geo-locate the aerial photographs. Note the identifiable procumbent tree trunks and the areas of overlying boulders.
© Historic England, Damian Grady

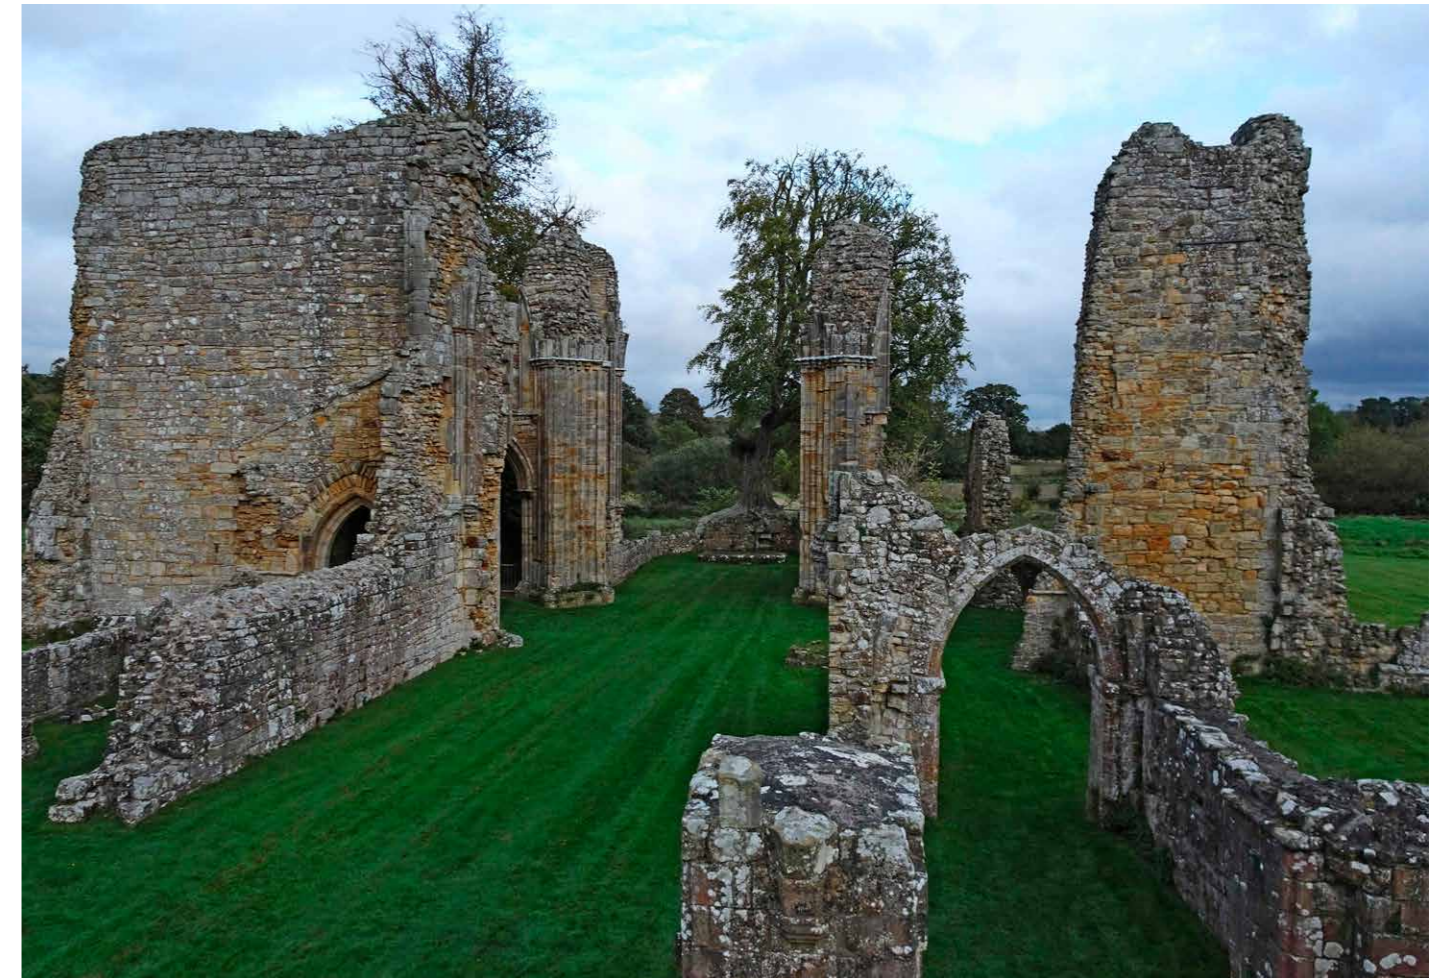
Top: View to east along the nave towards the remains of the enlarged church.
© Historic England

Bottom: A perfect fit for the GPR antenna through the chapter house.
© Historic England

We decided that a closely spaced ground-penetrating radar (GPR) survey using a vehicle-towed system would be best to cover the majority of the guardianship site, although careful driving was required to manoeuvre the lightweight all-terrain vehicle through the abbey ruins. >>

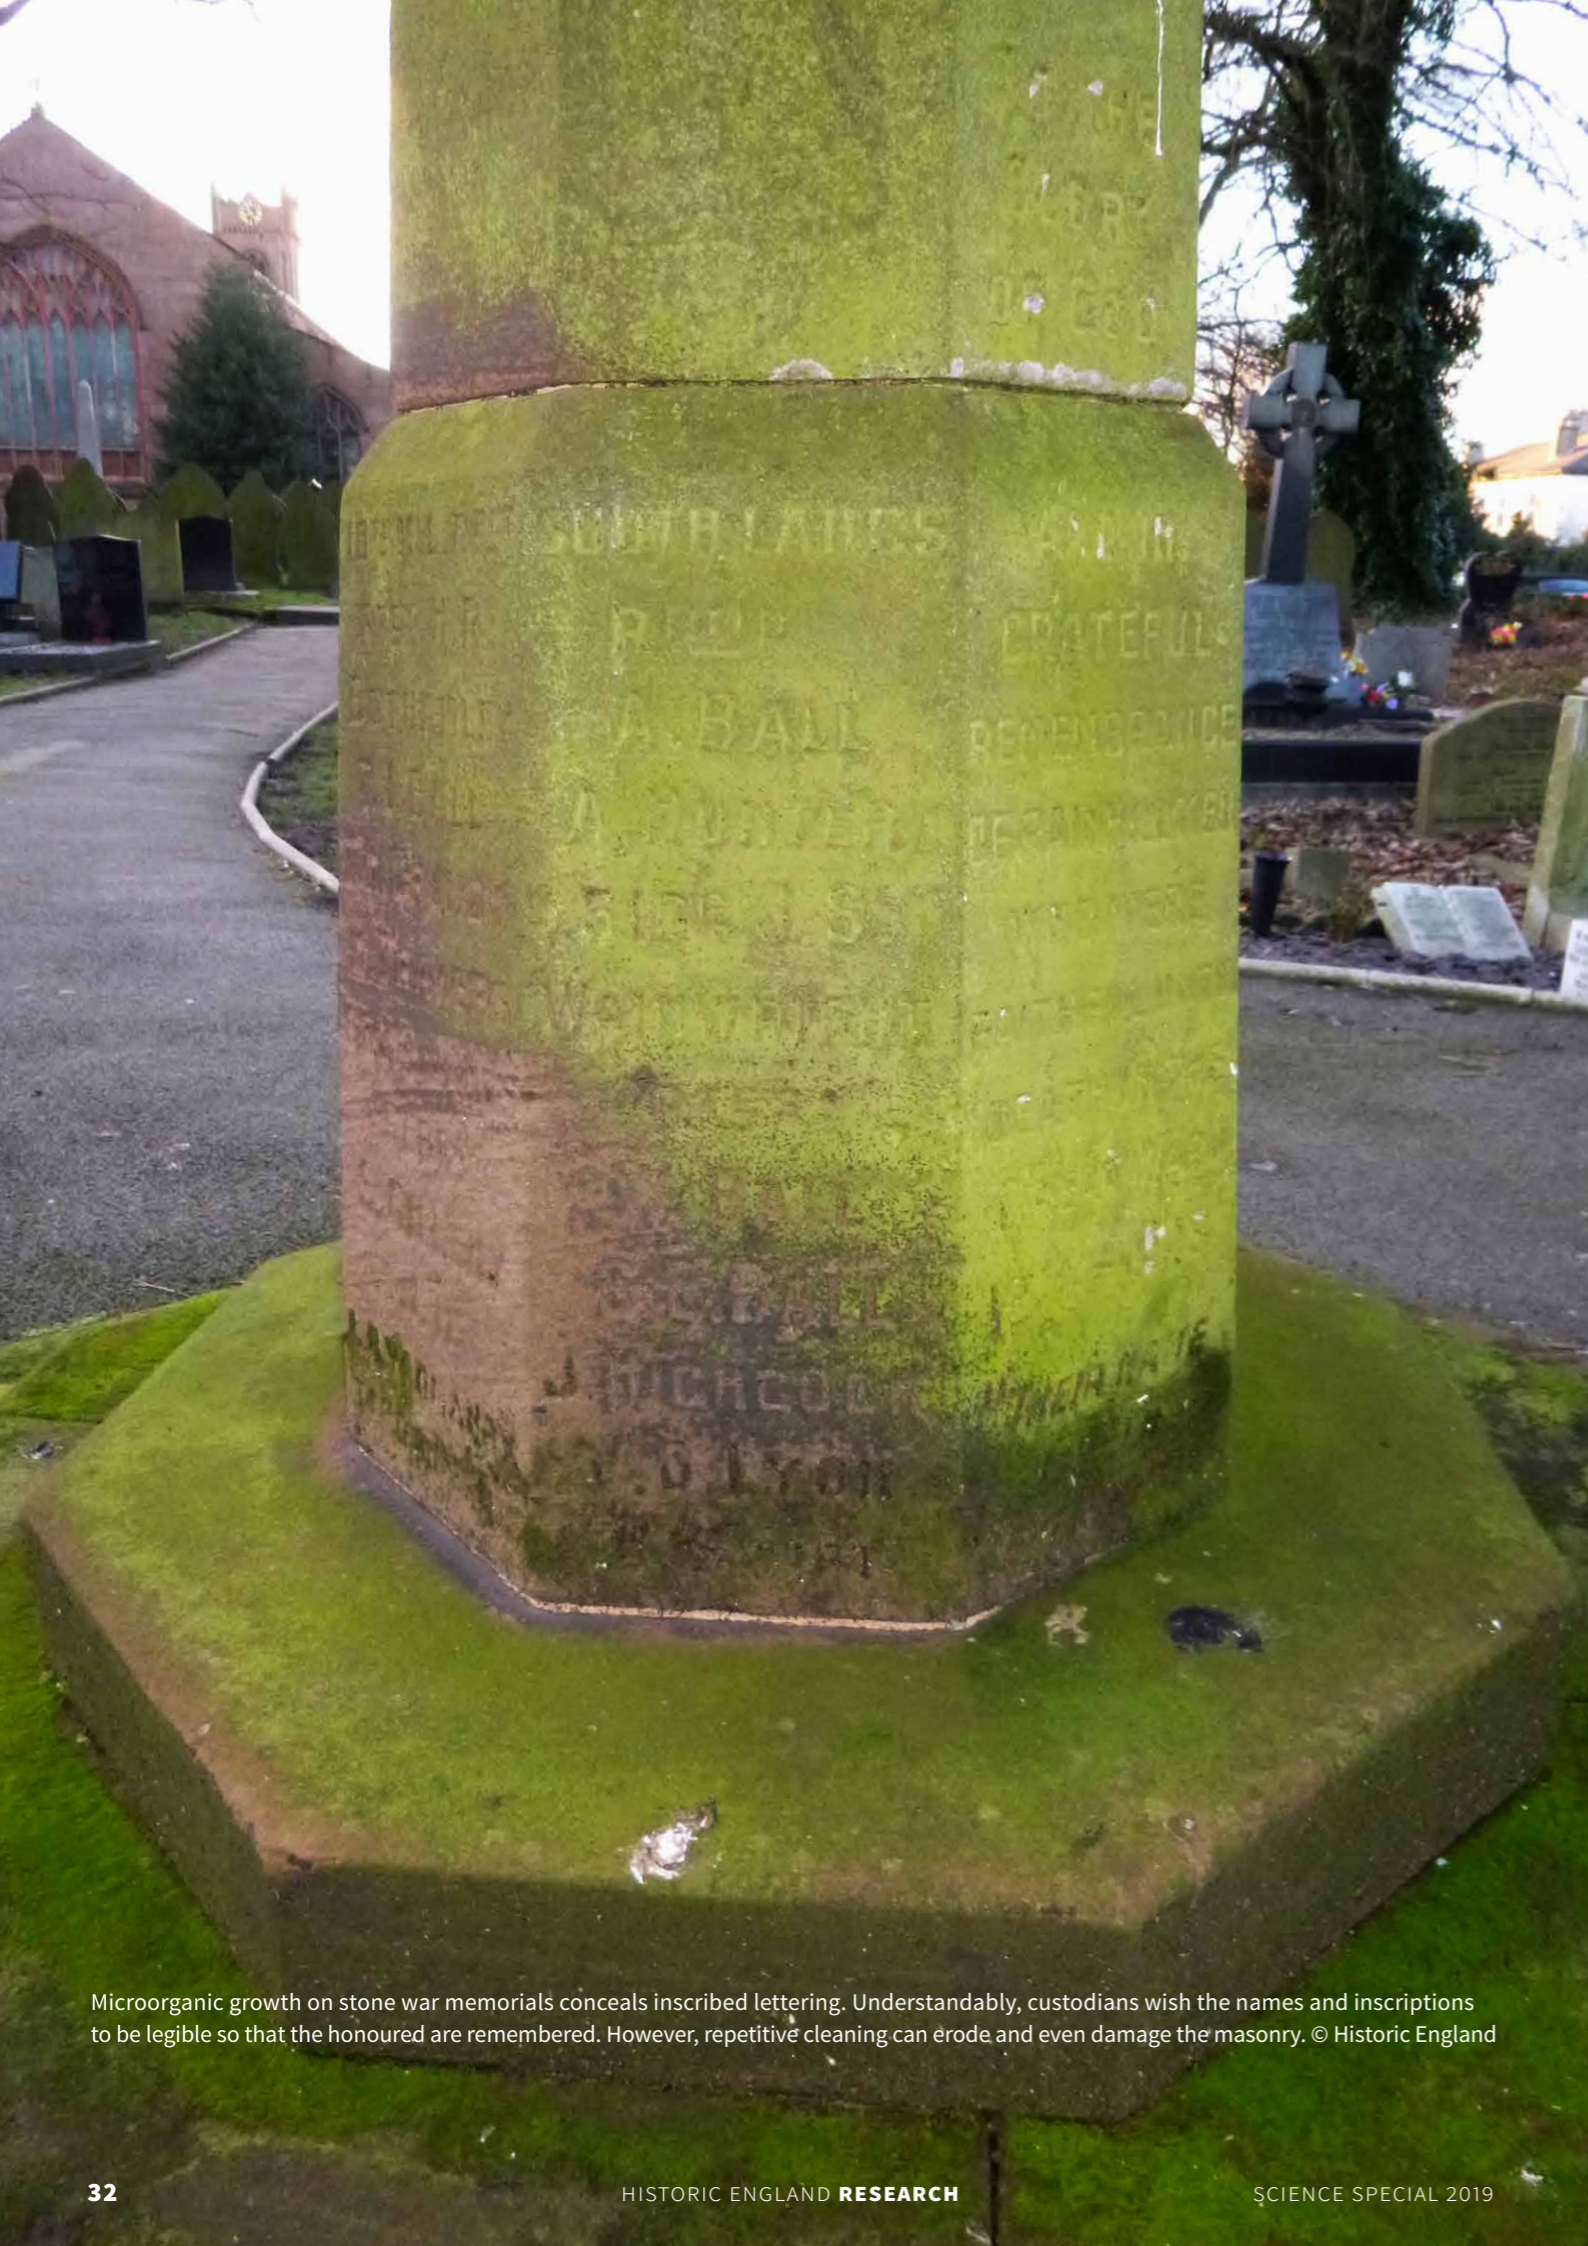
Microorganic growth on stone war memorials conceals inscribed lettering. Understandably, custodians wish the names and inscriptions to be legible so that the honoured are remembered. However, repetitive cleaning can erode and even damage the masonry. © Historic England

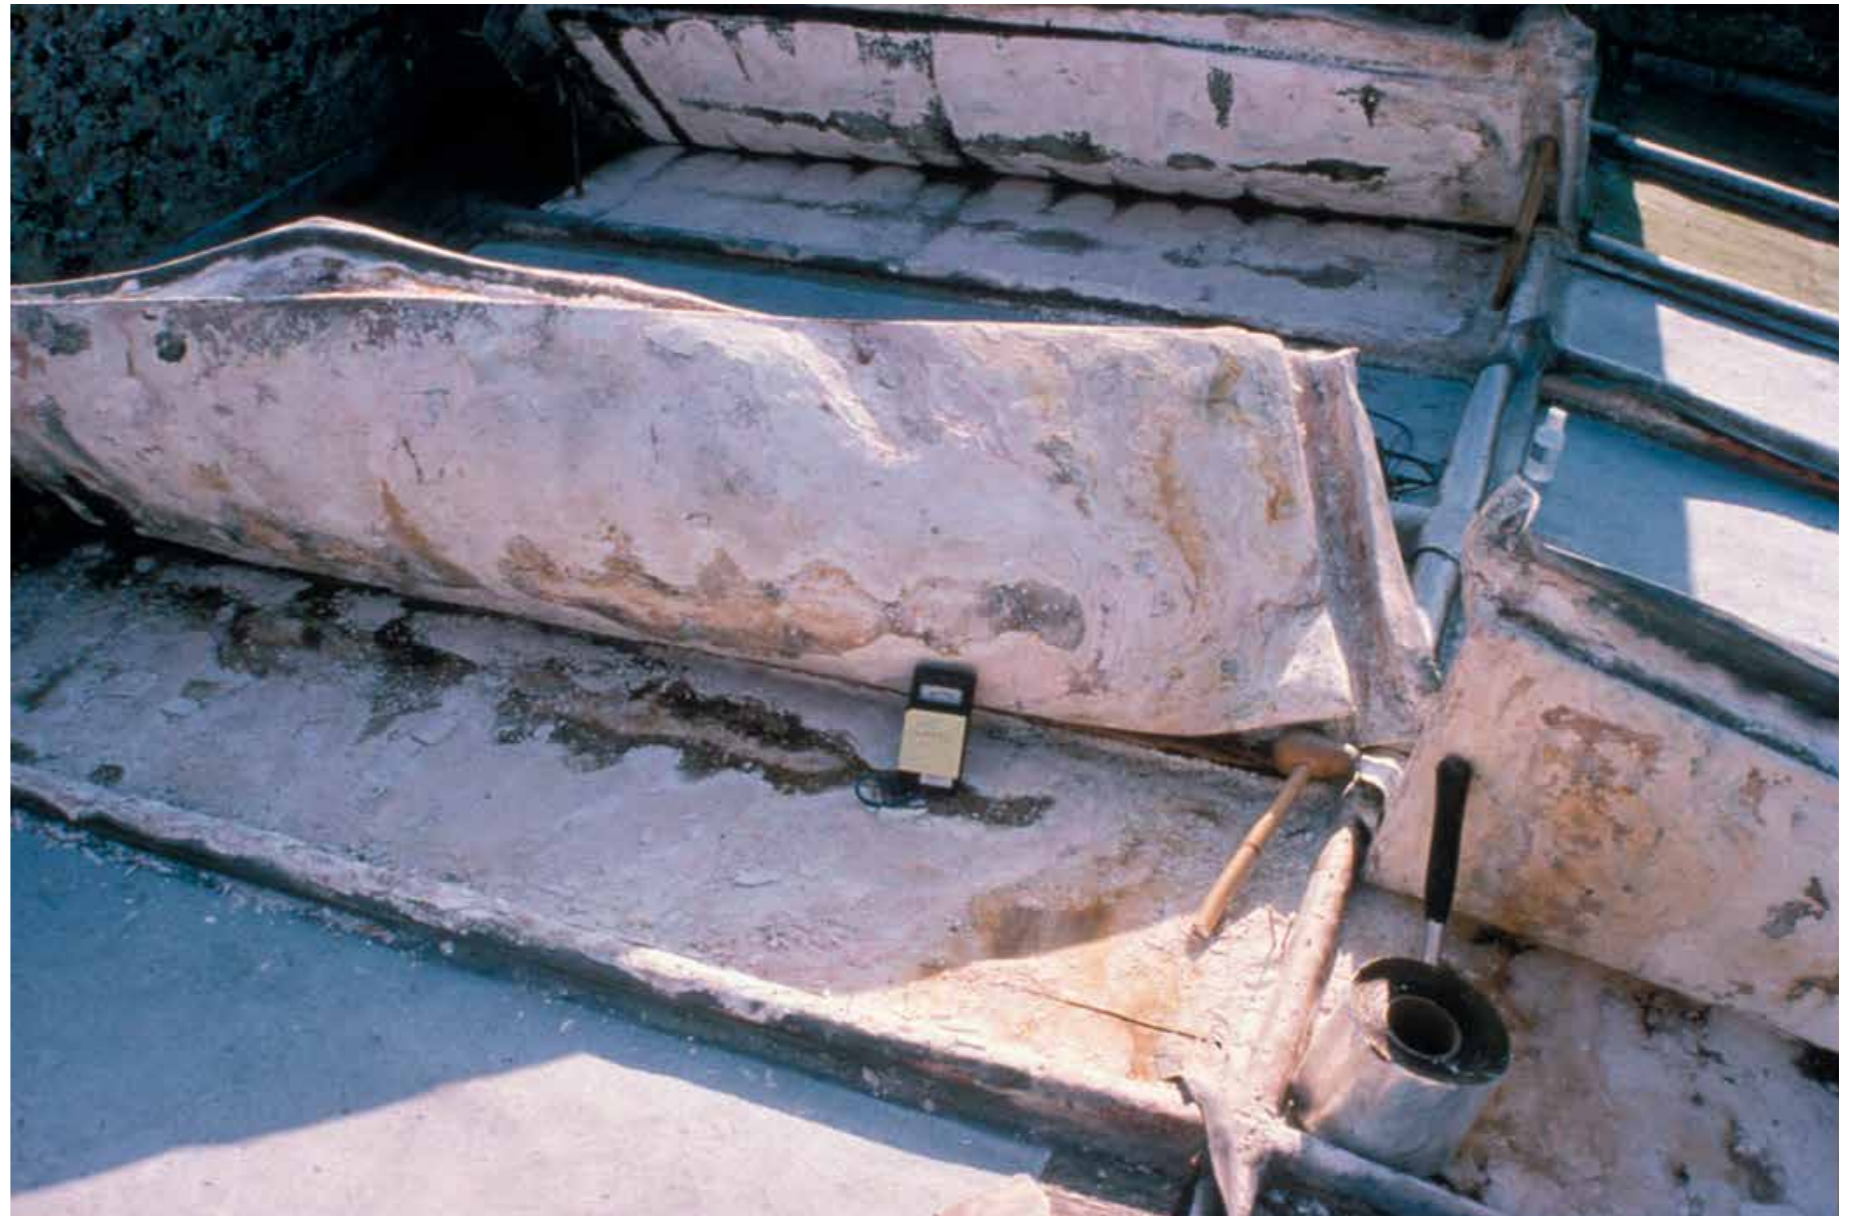
Above left: The Great Hall, Hampton Court, where chronic corrosion condensation meant that the lead had to be replaced within 40 years. © Chris Wood

carbon dioxide is present, any condensation will begin the corrosion process. This gets worse if there are acids present, coming from woods such as oak and from glues commonly used in hardboards and plywood. Industry’s solution was to change the design of the roof to accommodate a ventilated structure by lifting the plane of the slopes by 200mm, causing all manner of detailing problems on many historic roofs. What was needed therefore was a coating applied to the underside that could resist the onset of corrosion in order to maintain the existing design of the roof. >>

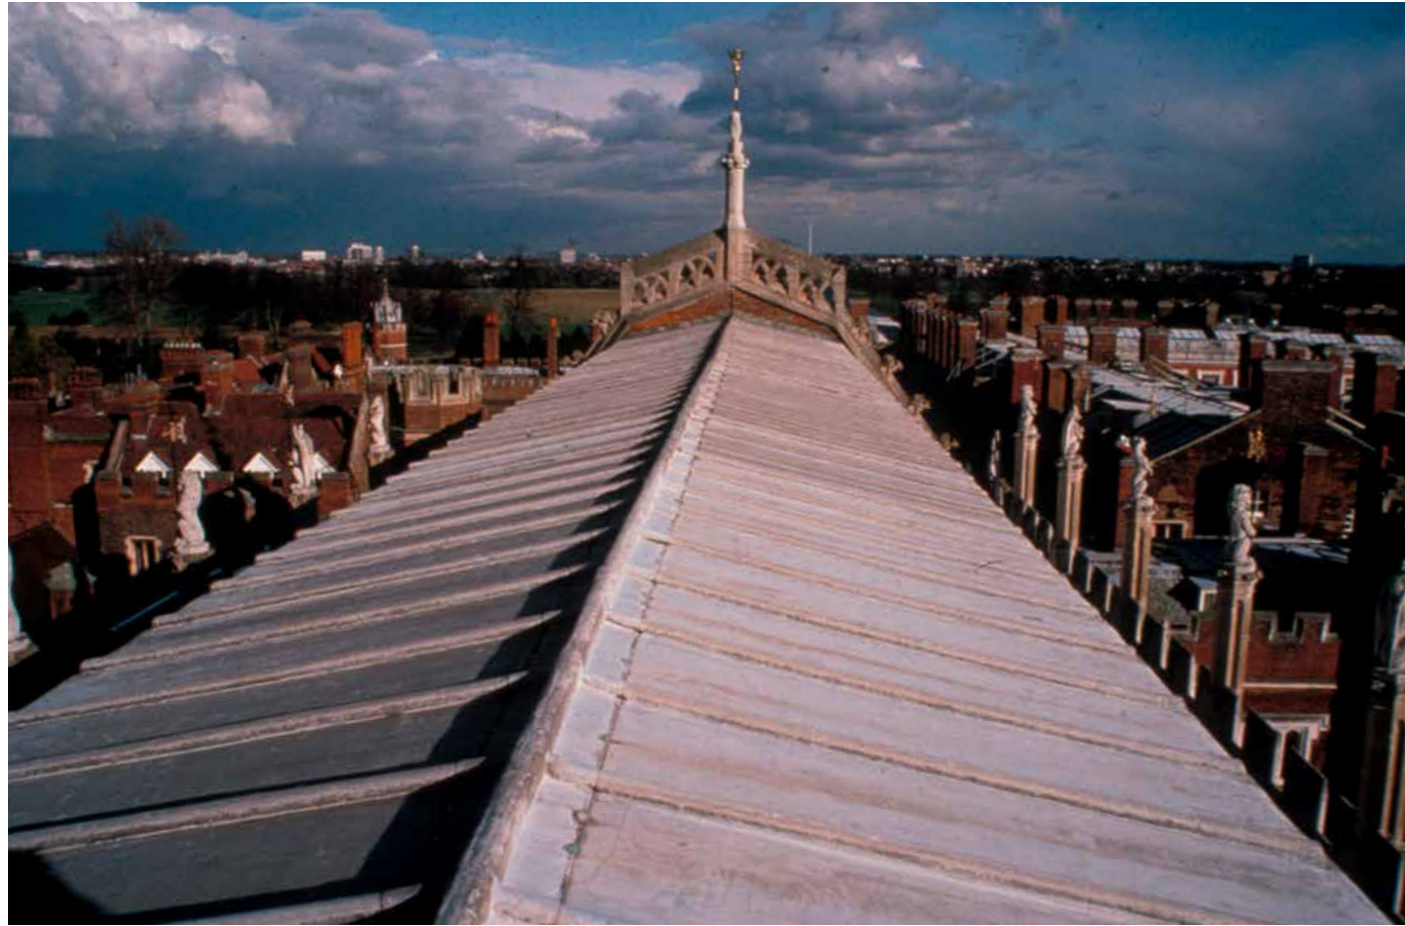
Below left: The new lead on the Great Hall roof at Hampton Court was given a coat of chalk slurry and shows no sign of underside corrosion after nearly 20 years, despite the very hostile environment. © Chris Wood

A simple mixture of chalk powder and water ('chalk slurry') proved to be effective. The carbonate ions in the chalk combined with the lead to form a protective layer of lead carbonate, which performed effectively in laboratory tests. Chalk slurry has now been used on many roof repairs. The mix was improved with the addition of a chalk-based paint which produced 'chalk emulsion', providing a far more adhesive and effective coating. Both systems have been monitored over the last twenty years on sites where the corrosion problem is particularly bad and so far they have proved effective at resisting corrosion. We will publish guidance later this year on the Historic England website. >>

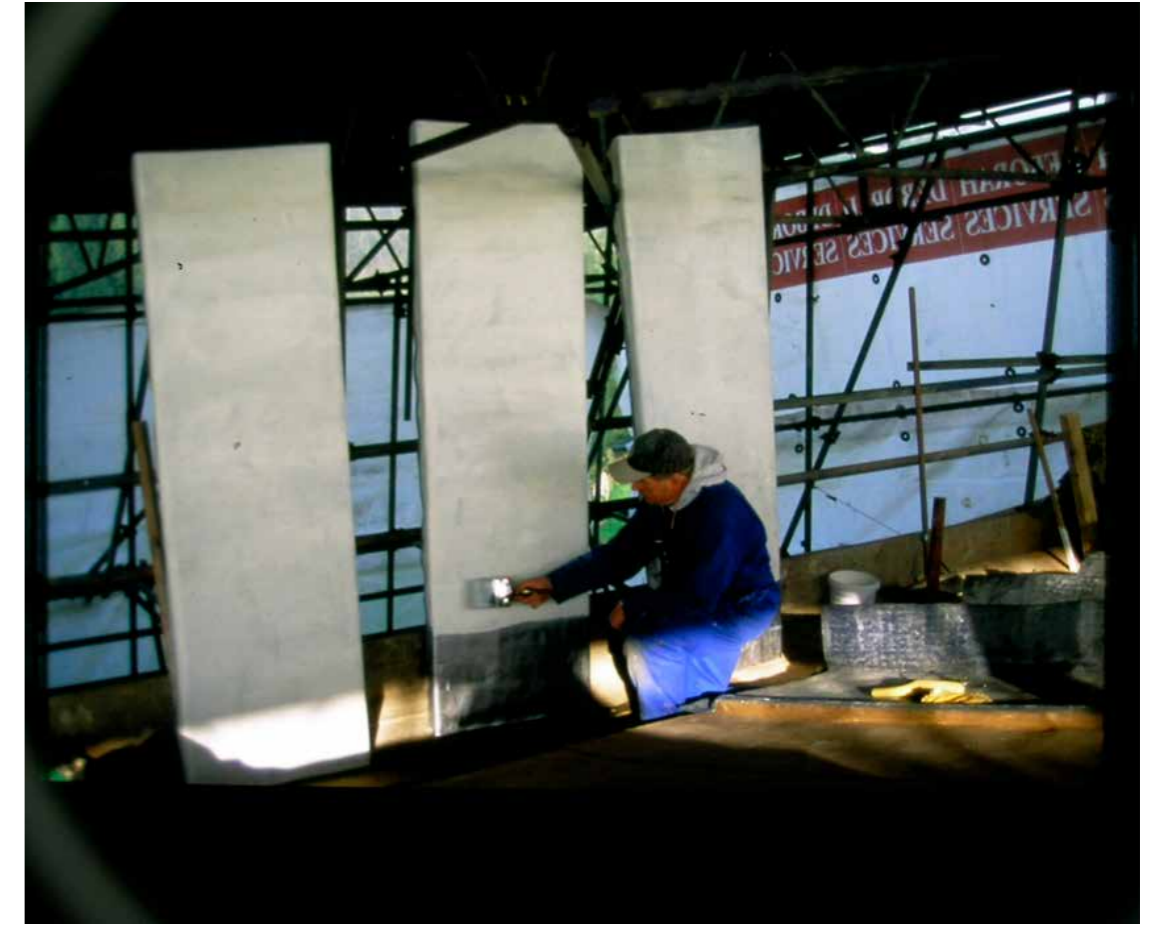
Above right: Chalk emulsion being painted onto lead sheets before fixing onto the roof. A green dye is now applied to easily distinguish the emulsion from the corrosion product. © Chris Wood
