Discovery, Innovation and Science in the Historic Environment

RESEARCH

ISSUE 12 • SCIENCE SPECIAL 2019

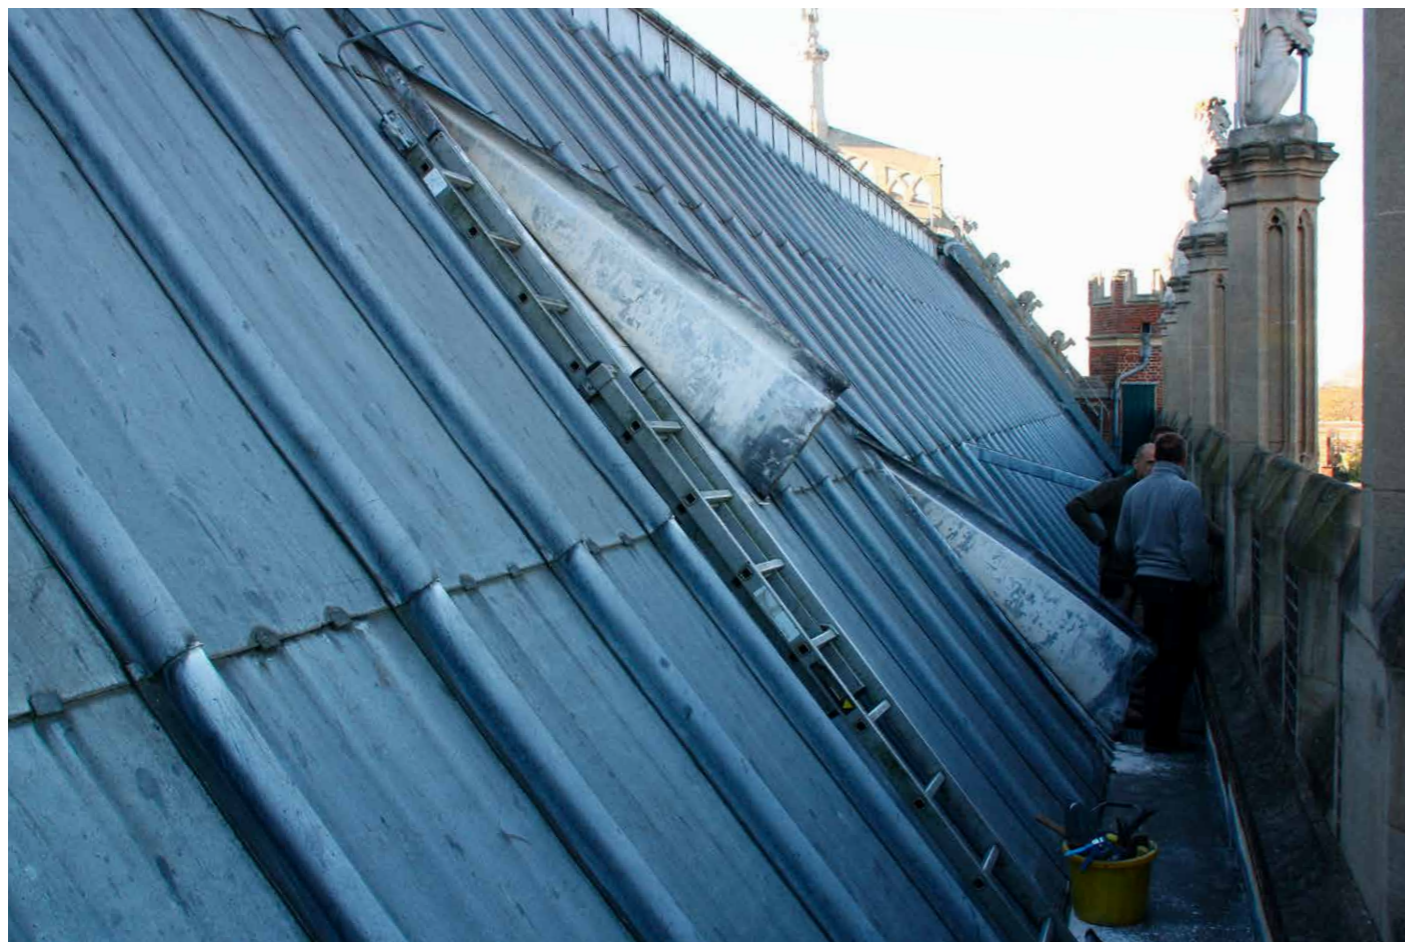
Above right: Chronic underside corrosion, made worse with acid attack, has eaten through this Code 9 lead at Donnington Castle Gatehouse in less than 40 years. Normally this quality of lead should have lasted well over 100 years © Chris Wood

Below right: Donnington Castle Gatehouse which proved to be an excellent testing site. Chalk emulsion has kept the lead samples free of corrosion for 15 years but the non-treated areas have been badly attacked © Chris Wood

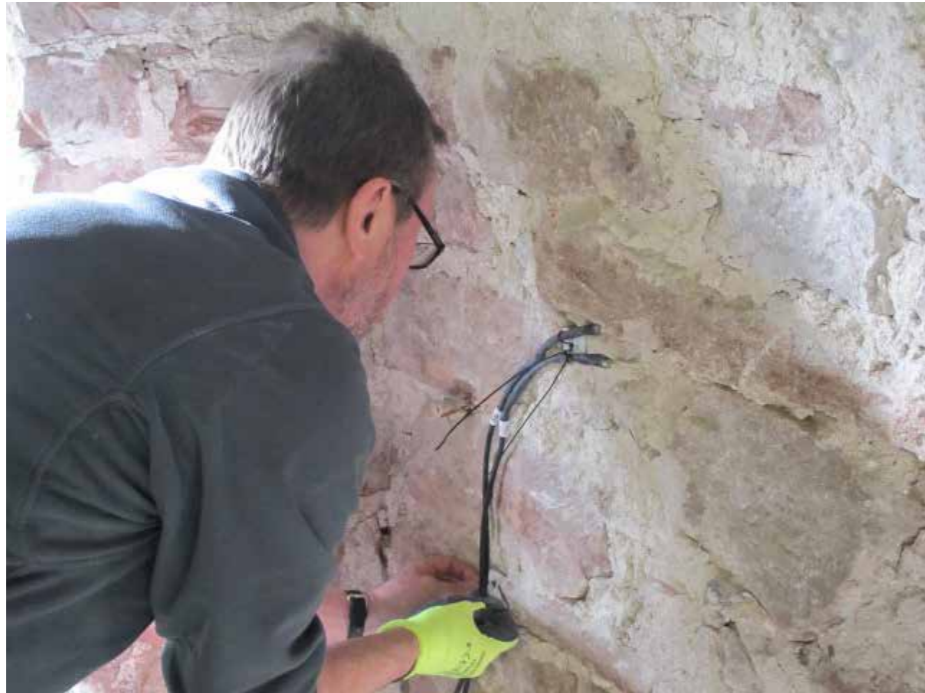
Right: Fixing the sensors at Chapel Street, Appleby, prior to the installation of lime hemp insulation.
© Historic England

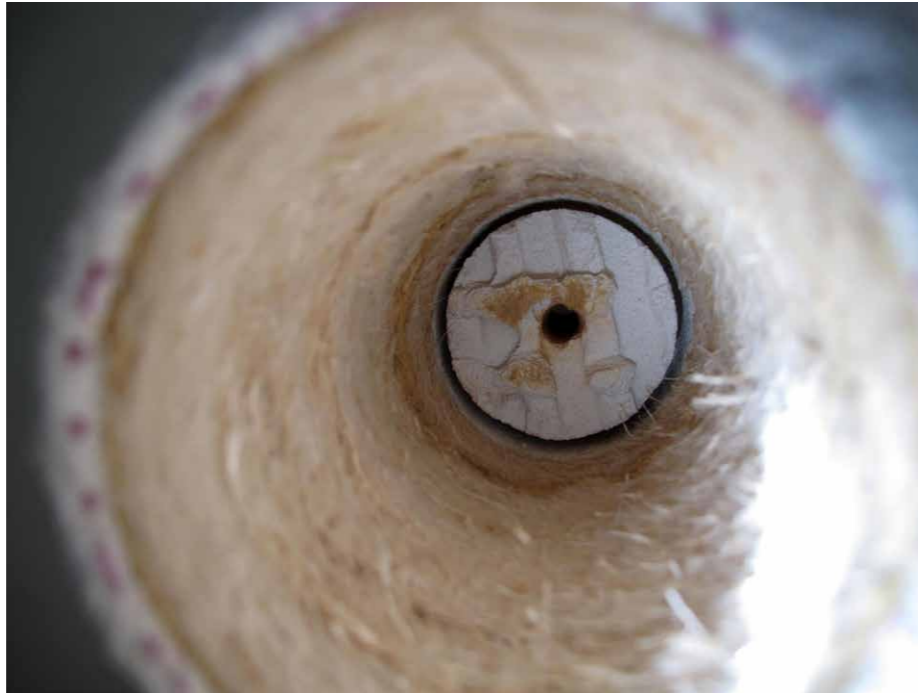
Top left: Cores were drilled into internal wall insulation systems to assess their condition. No signs of deterioration were observed in either the PIR or the wood-fibre insulation systems (shown above). © Historic England

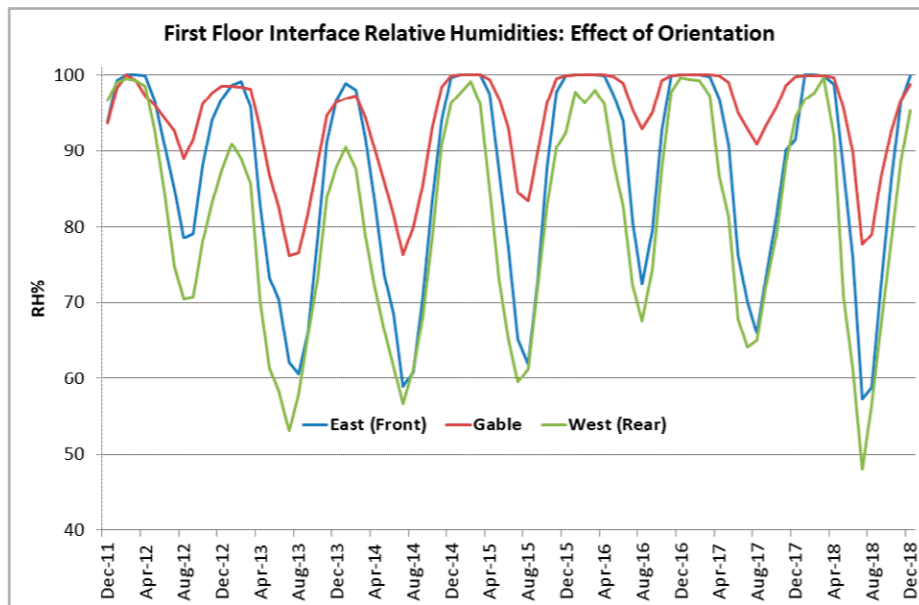
Bottom left: New Bolsover: measured relative humidities on the first floor at the wall/wood-fibre insulation interface. The graph shows accumulated moisture over the last seven years and the effect of the seasons and orientation. © Historic England

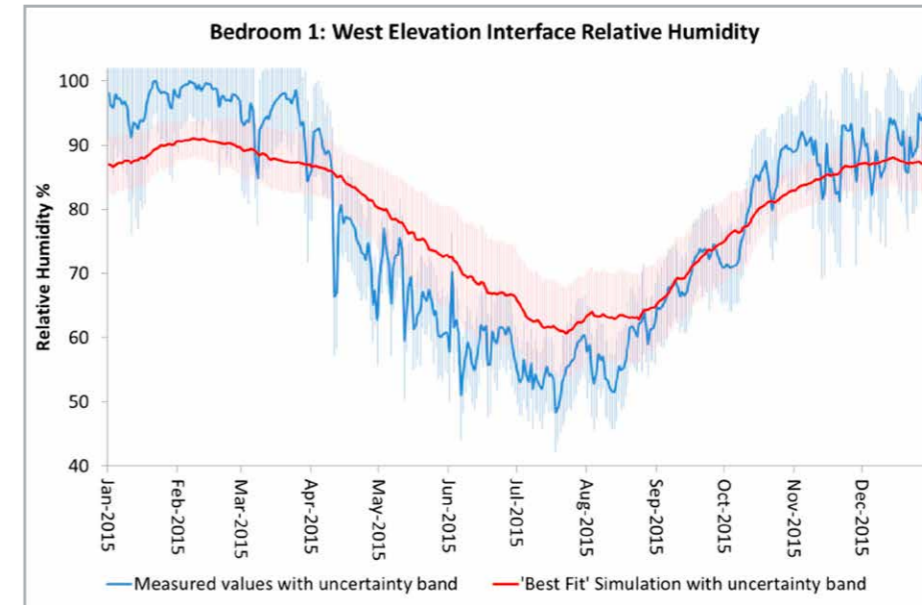
Top right: Comparison of modelled and measured relative humidities of the exposed west elevation with wood-fibre insulation on the first floor during 2015. The graph shows reasonable agreement between the two datasets, though the simulation overestimates the moisture levels during the summer and underestimates the moisture levels during the first part of the year. © Historic England

- and when modelled, using the measured results as input data, we found broad agreement for the exposed west elevation but a less good fit for the sheltered south elevation, particularly during the colder months. >>

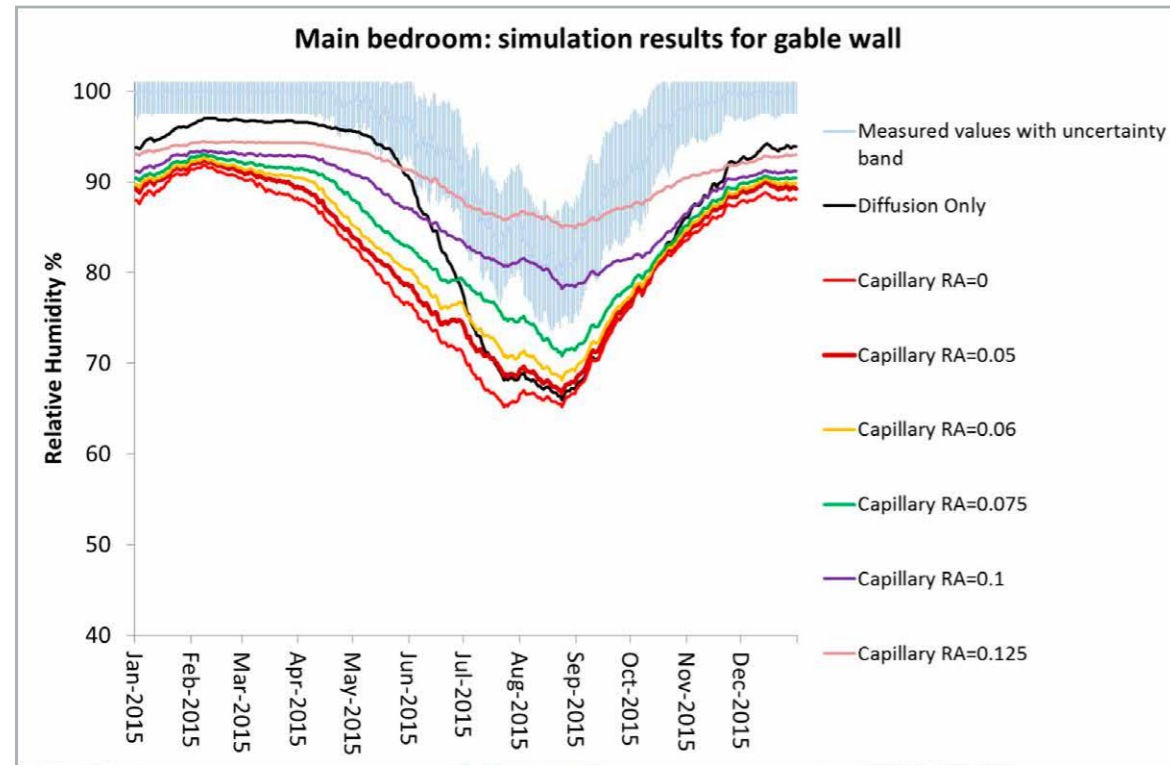
Above: A comparison of the measured and predicted interface relative humidities of the wood-fibre insulation on the south elevation on the first floor during 2015. The graph shows a range of relative humidities that can be achieved by using different rain adherence factors (RA). Generally for the RA values 0-0.075 of the simulation results, whilst tracking the dynamic behaviour of the measured data, they underestimate the latter by about 10 per cent relative humidity. © Historic England

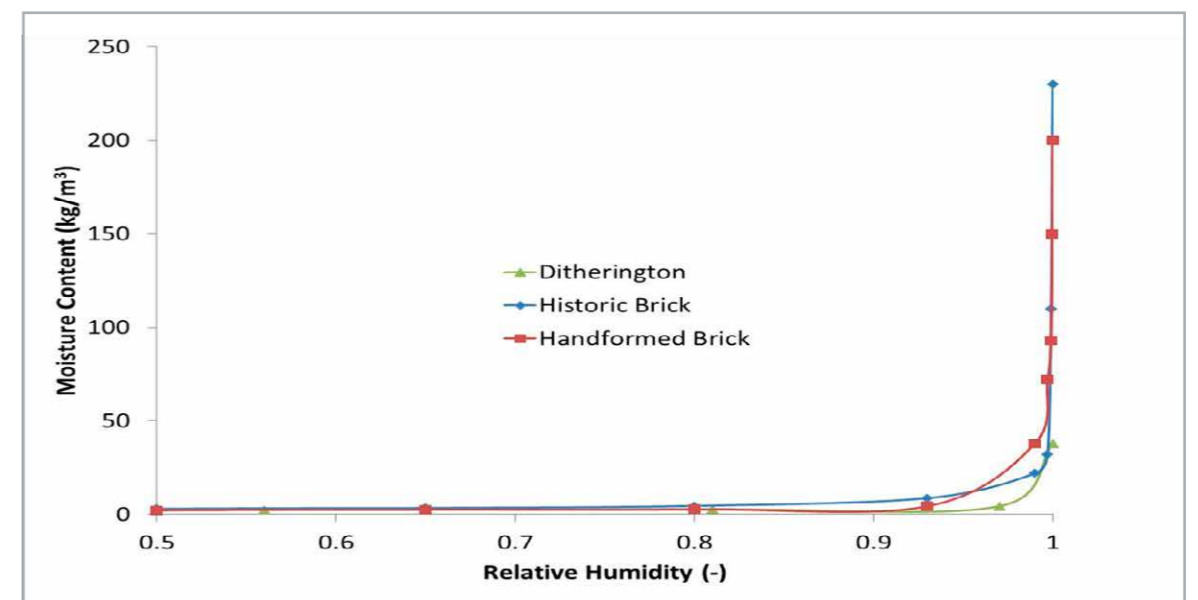
Bottom: Material testing of the Shrewsbury Flax Mill brick (Ditherington in the graph) has provided lower moisture absorption at high humidities compared to the WUFI 'library' historic and handmade bricks. © Historic England

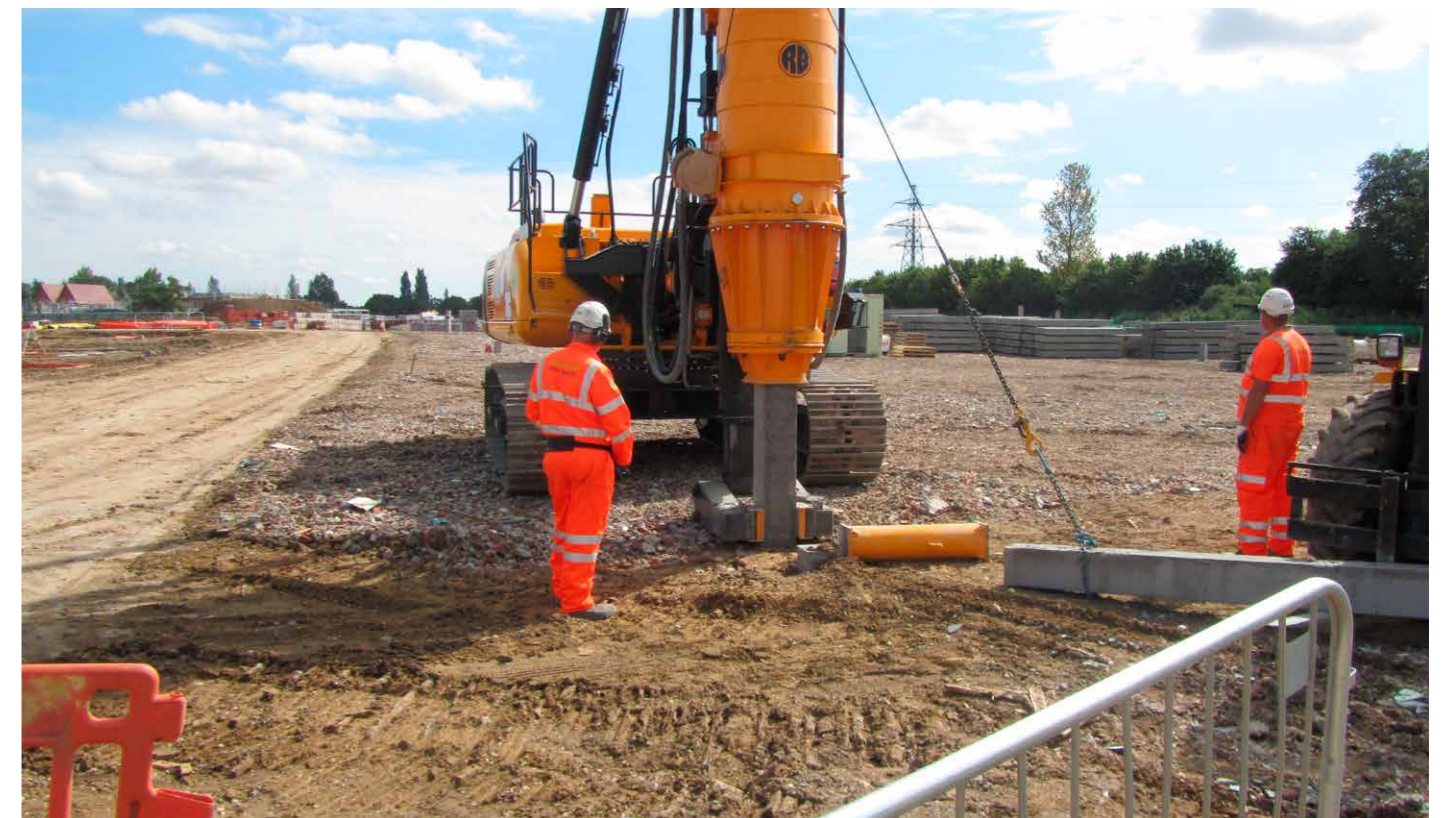
Above: Installing sections of a preformed concrete pile. © Roger Bullivant Limited
