Historic England

Water Meadows

Introductions to Heritage Assets

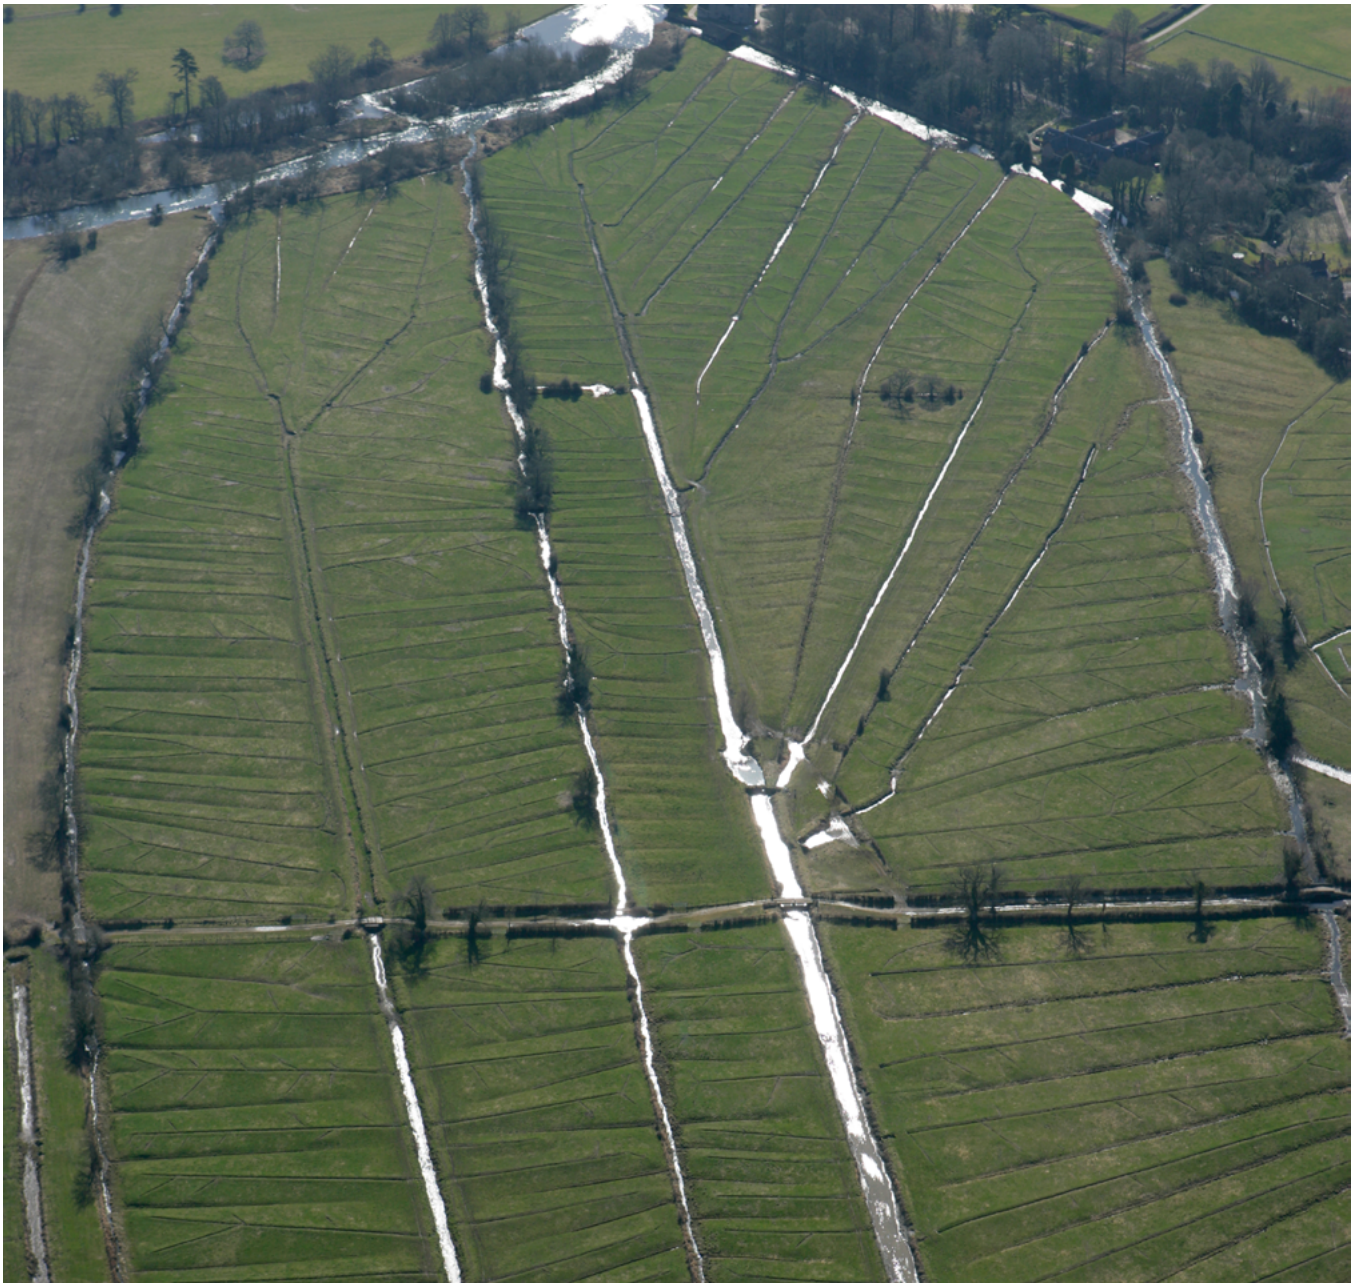
Front cover

Water meadows at Alderbury on the River Avon, south of Salisbury (Wiltshire). They were part of an extensive (250 a) and well-documented system constructed along a four-mile stretch of the river between 1665 and 1690. The scheme was financed by Sir Joseph Ashe (a wealthy cloth merchant) and constructed by his steward, John Snow.

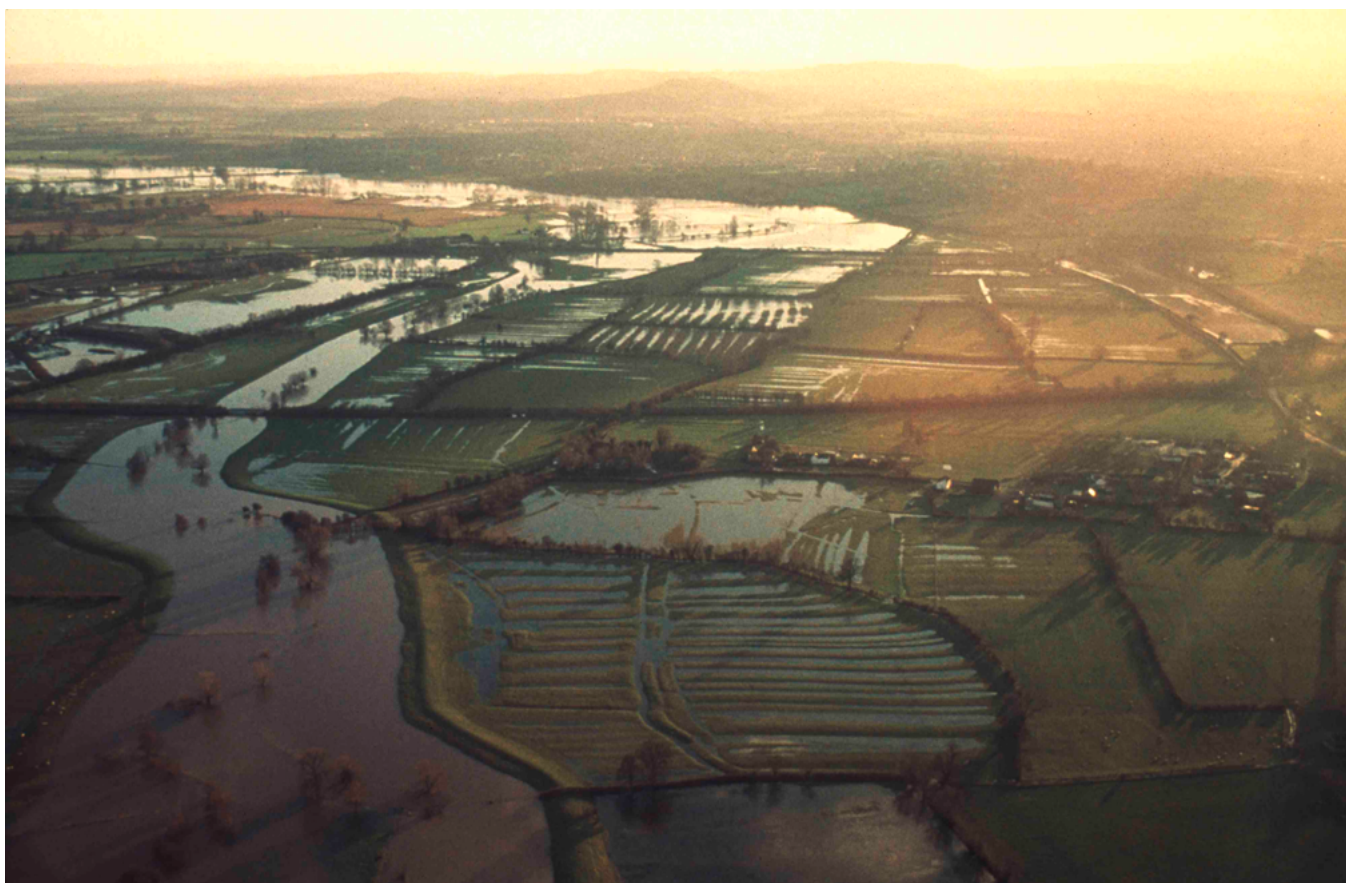
Figure 1
Water meadow earthworks on the River Lugg,
Herefordshire, picked out by floodwater.

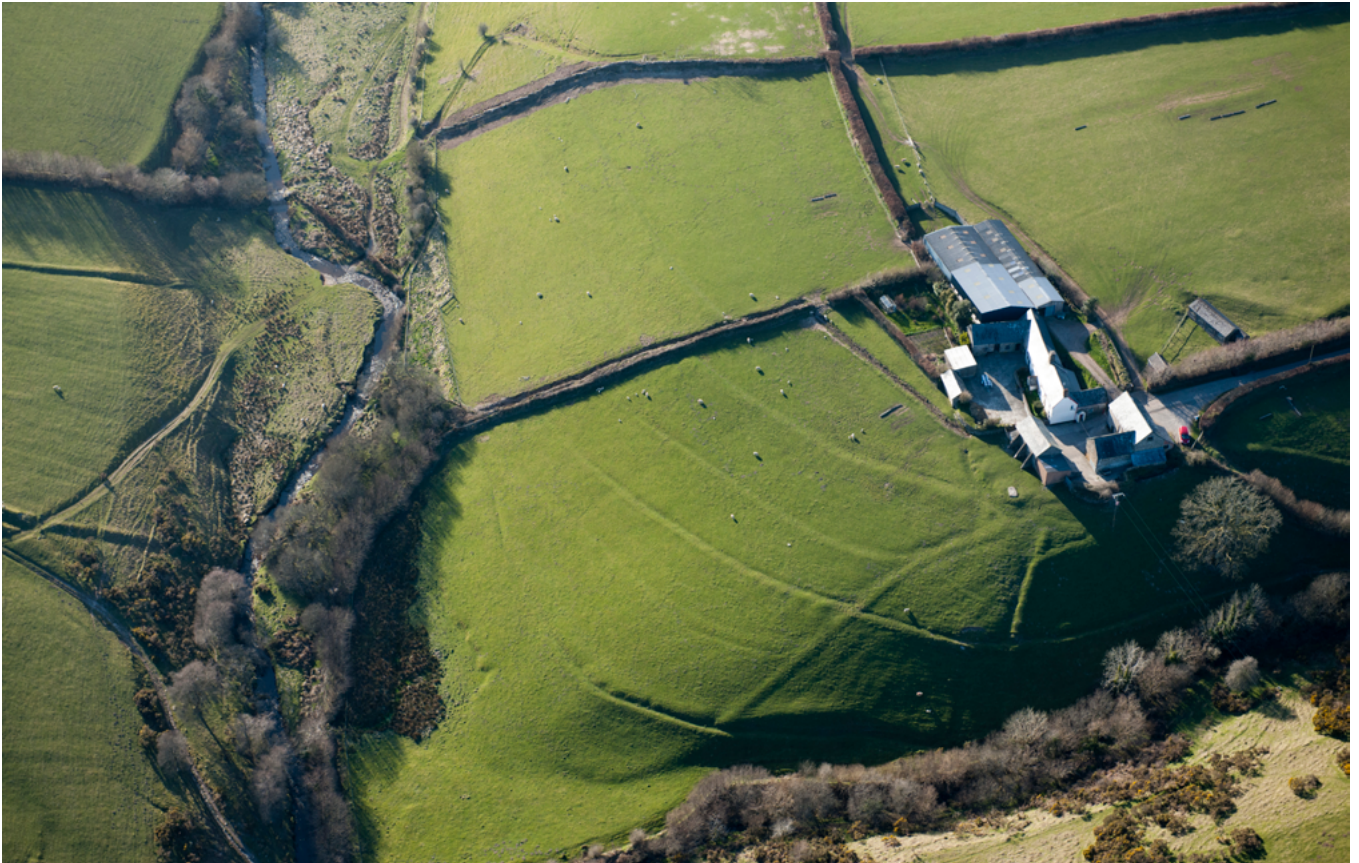
Figure 3

Catchwork meadows are evident today as parallel contour-following channels ('field gutters') on hill slopes, as seen here at Cloggs Farm, Somerset.

The simplest form of downward floated water meadow was the catchwork (also known as a 'catch meadow' or 'field gutter' system). Catchworks used spring water or hill-side streams to irrigate valley or hill slopes. If neither of these water sources was available rainwater and farmyard run-off was collected in a specially-constructed feeder pond. Water was diverted from the source into a contour-following ditch or 'gutter' which skirted the top of the meadow. When the gutter was blocked by 'stops' of turf, peat or logs, or by using more permanent sluices, water overflowed down the hillside and irrigated the area of meadow below. Further downslope, additional gutters parallel to the first caught the run-off and redistributed it in a similar manner to lower pastures. The process encouraged an even flow of water down the slope. At the base of the meadow surplus water was collected and carried away via a drain (Figures 3 and 4).

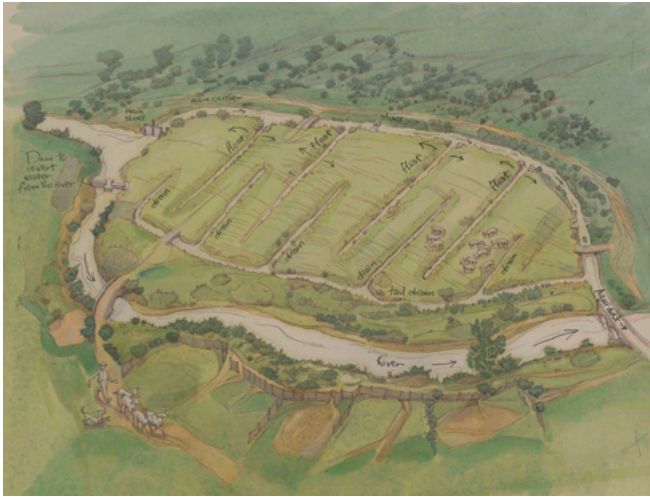
Figure 5
Reconstruction drawing showing a typical bedwork water meadow.

Bedworks thus appear as prominent ridges with interlocking channels. The widths and heights of the ridges range considerably, from 3-15 m (commonly 5 m) wide and about 0.5-0.6 m high. They can resemble the plough ridges of former cultivation and recent research has indicated that some early ridge-and-furrow might have been re-employed for water meadows. However, the layout and form of the ridges, their location, and the presence of water control structures and additional channels all help to distinguish bedworks from ridge-and-furrow (Figure 5).

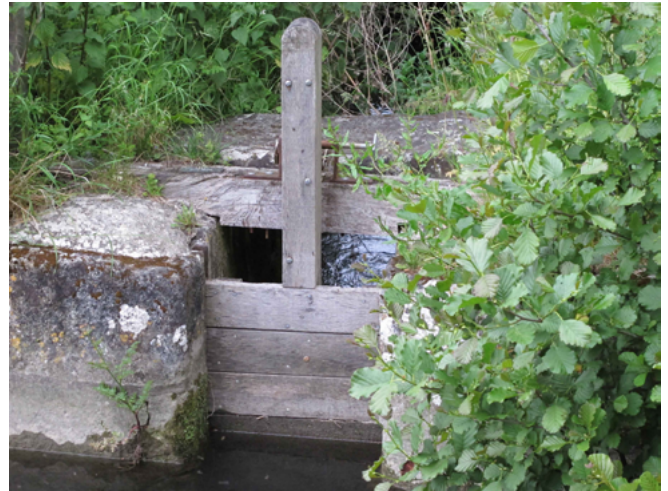
Figure 8
A restored water meadow hatch in use today at Harnham, Wiltshire.

Bedwork systems had a main weir or dam to divert water from the river or other source and subsidiary weirs and sluices (one-hatch weirs) on smaller carriers to ensure an even distribution of water. These structures came in a variety of materials depending on what was readily available at the time of their construction (Figure 8). Early hatches were simple boards which slotted vertically into wooden frames or stone settings and were raised by peg and hole arrangements (Figure 9). Later, materials such as brick and cement were used for hatch settings and their boards were fitted with iron ratchet and crowbar raising mechanisms. At the beginning of the 19th century cast iron weirs and hatches came into use. The majority of these structures are ruinous today, but collections of loose material near the banks of rivers or streams may indicate their former sites or the presence of buried examples.

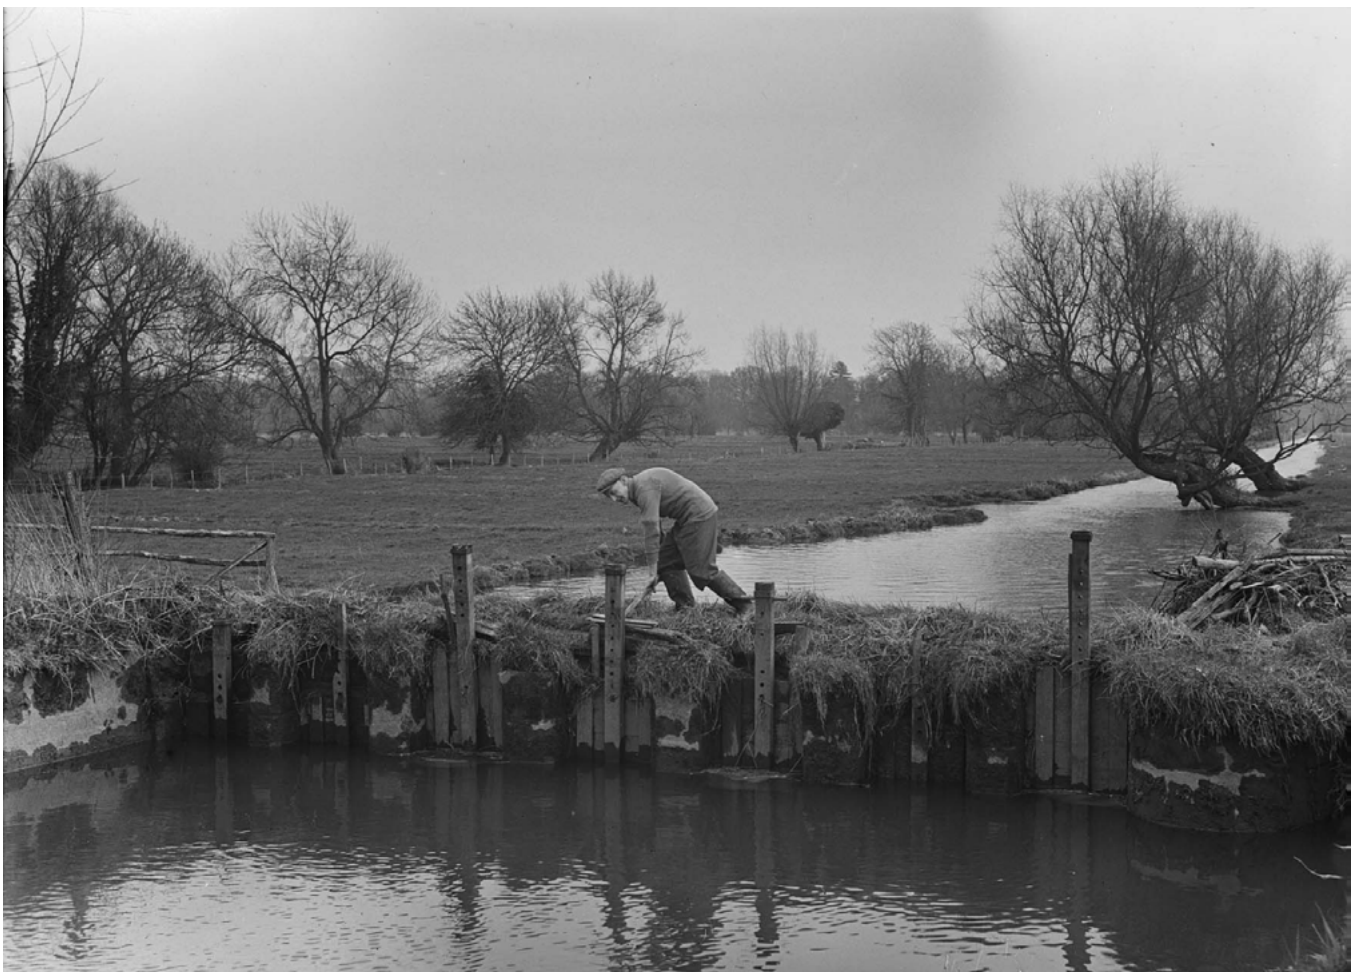
Figure 9
A drowner at work on a seven-hatch weir at Lower Farm, Britford, near Salisbury, in 1954.

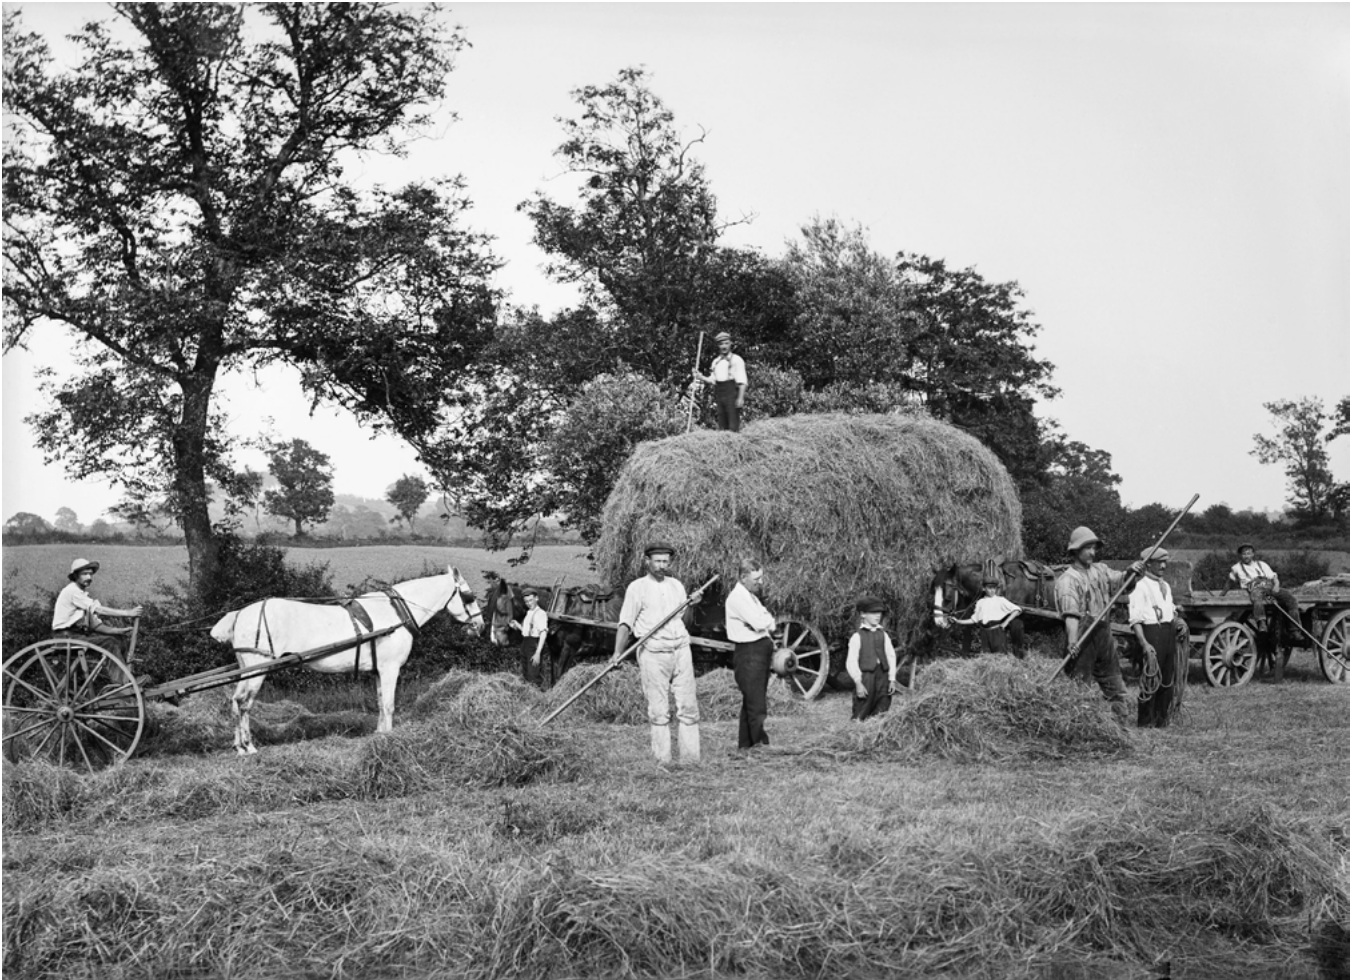
Figure 11

Haymaking at Byfield (Northamptonshire) around the time of the First World War. The dried hay, lying in windrows, is being loaded onto wagons; one has an almost full load; the next waits to the right. On the left is a horse-drawn hay rake, used to scrape up the scattered remnants of the valuable crop.

Working in a line, haymakers moved methodically across the meadow, cutting the lush grass with long-bladed scythes, which would be kept razor-shape with whetstones. This process left the cut grass in lines, and women and children would use pitchforks and rakes to turn and fluff the grass in these 'windrows' to speed even drying. Typically this would take a couple of days, and overnight the hay would be raked into heaps – haycocks – to minimise any damage by rain or heavy dew. In the morning the cocks would be opened up, and the turning resumed (Figure 11).

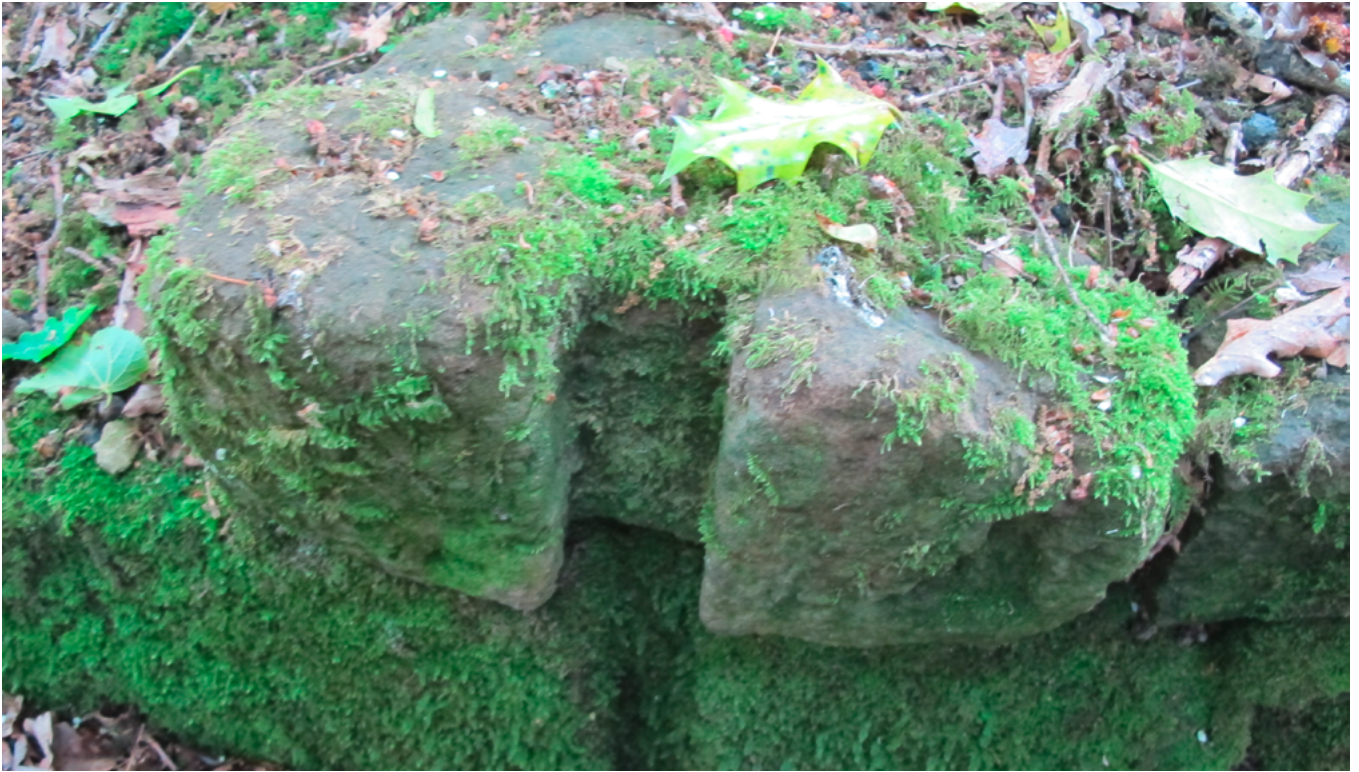
Figure 12
Slotted stones are often all that remains of water meadow sluices. They are difficult to date without evidence from other sources, though later sluices were frequently brick-built.

Built structures provide further clues, although many will have replaced earlier structures and so indicate the later stages of a water meadow's period of use. It is possible to estimate the date of bricks by their size, shape or maker's marks, to recognise 19th century concrete and to identify the sources of stone used. The presence of hatch settings and bridges of rough-hewn stone blocks may indicate an early water meadow, constructed before the mid-18th century when brick became freely available (Figures 12 and 13). Later hatches sometimes had iron mechanisms – levers and rack and pinions derived from water mill technology - to assist in raising and lowering hatches. In 1811 Hossey and Galpin of Dorchester produced the first cast-iron weirs and hatches, which were far more durable than earlier wooden ones. Many more were produced in local foundries between 1880 and 1910. Sometimes there may be an inscribed date on a built structure, though this is unlikely to date the whole system.

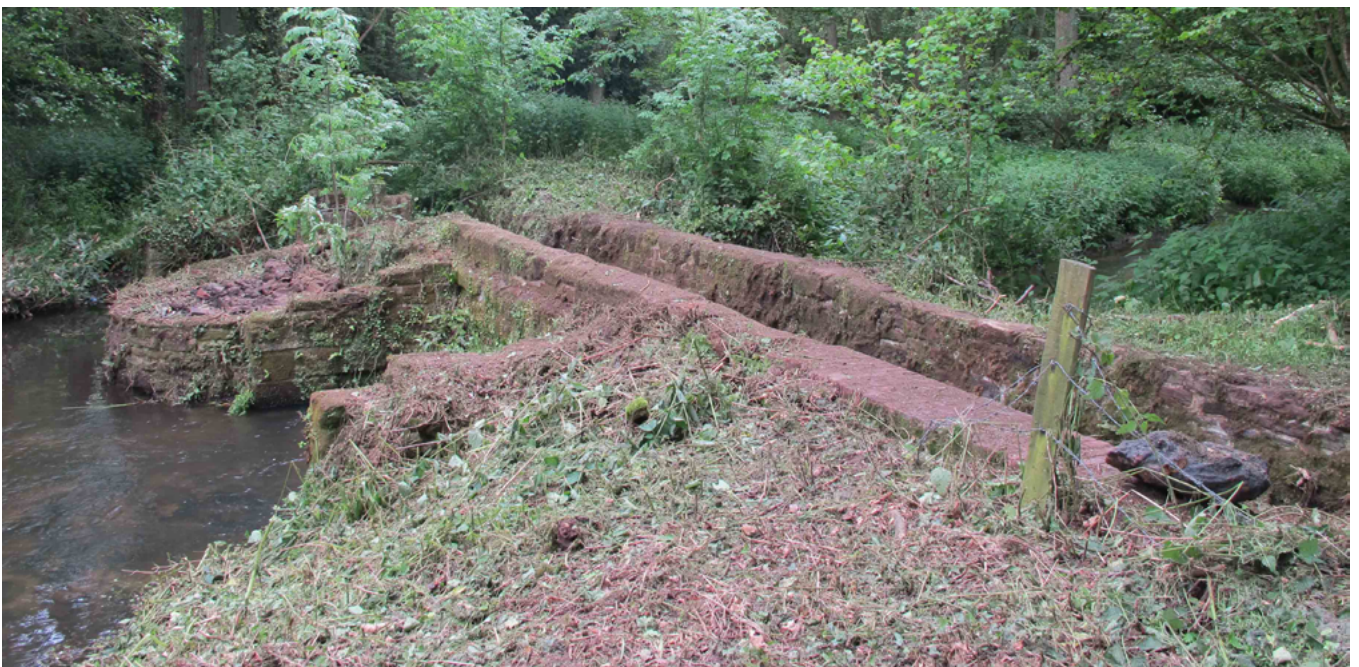
Figure 13
Aqueducts carried water through narrow sections of the Wey Valley, allowing its water meadow systems to function in difficult topography. This example at Bramshott Court is one of several built to connect water meadows on either side of the river.
