Historic England

Lead roofs on historic buildings

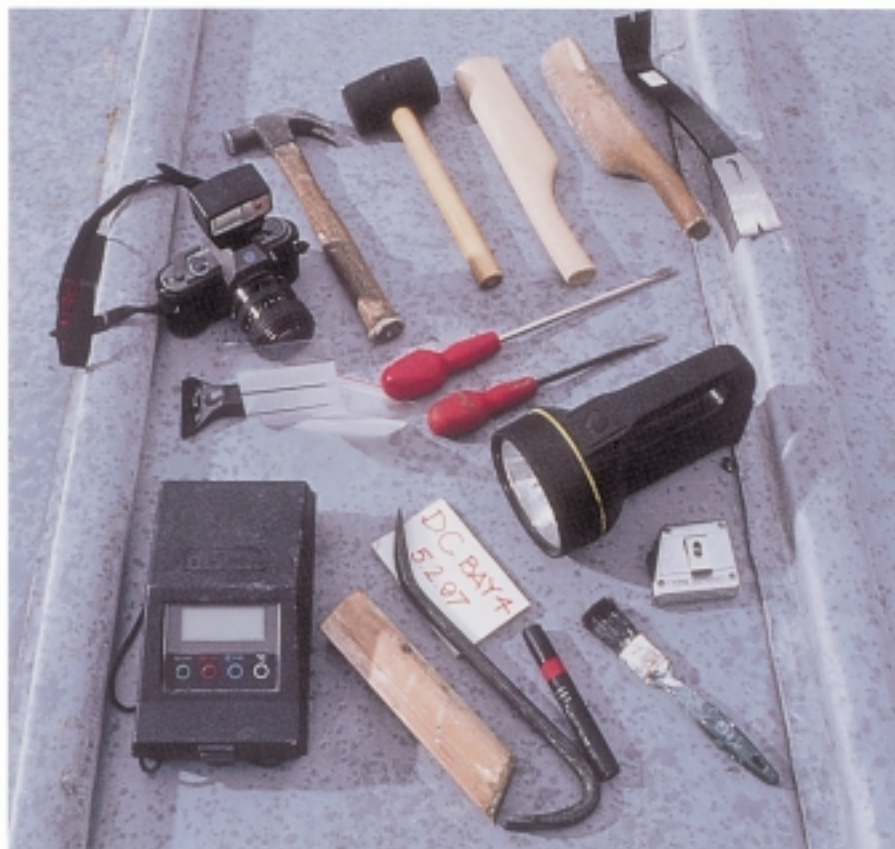
Figure 25 Typical set of equipment

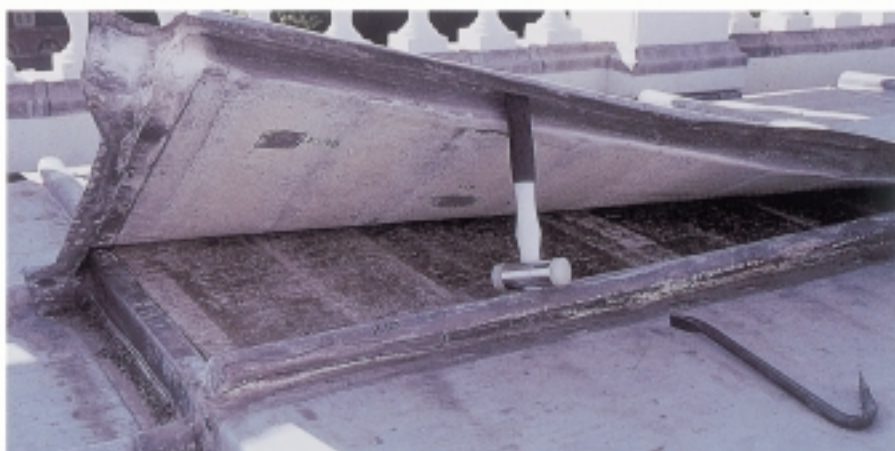
Figure 26 A sheet with its corner raised and propped

If the lead begins to lift at the bottom, support it there and try higher, aiming to loosen the whole length over the roll. If so, work up from the corner but take great care not to kink the lead over the roll. If kinking starts, ease back immediately and try to lever the lead away from the batten under the kink. Once the lead has begun to lift, check what is happening at the bottom (avoid kinks here too) and at the far side where the lifted sheet forms the undercloak: this may also need easing to permit free movement, particularly if there is a splashlap. Normally the corner can be lifted safely by between 200

and 300mm and propped in this position, to permit inspection and photography (see Figure 26).

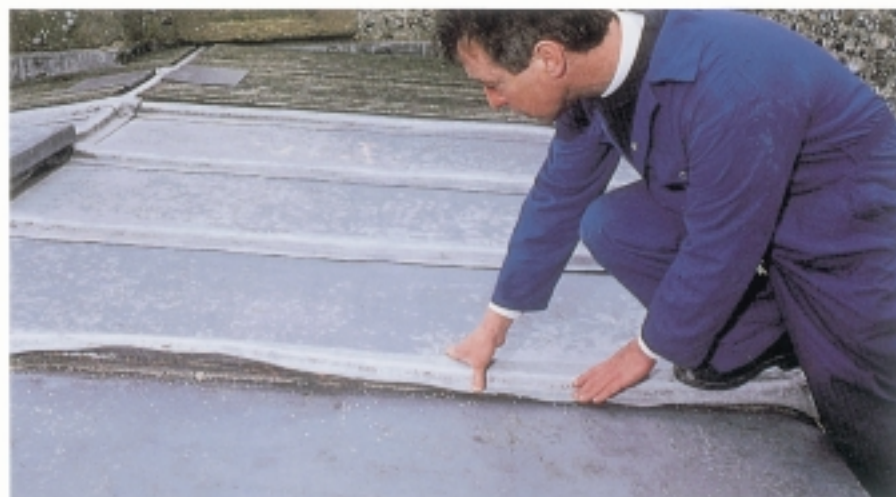
Figure 27 Replacing the lead

Lead which has been lifted carefully can often be lowered gently back into position and worked down by firm hand and finally foot pressure. Be gentle: bossing too early can make it difficult to return the lead into place. When lowering, it is important that the upper sheet drops properly into the inside of the roll: sometimes the edge of the undercloak is bent upward when the sheet is lifted, and needs to be pushed back down first. Once the overcloak is nearly back into position, it will need final bossing-down to help the joints close reasonably.

DO NOT knock the outer edges back down first: instead work towards them from the inside of the roll and only tap them finally into place. Try to avoid bossing the lead into the base of the roll as this will make the sheet more difficult to remove on another occasion. It is often gentler not to hit the lead directly with the dresser, but to place the dresser in the required position and to tap it with a rubber hammer.

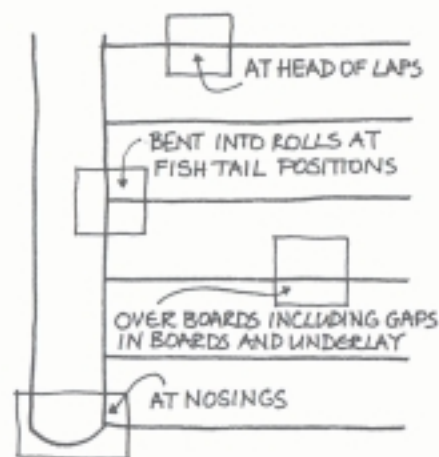
Figure 29 Typical corrosion sites and possible locations for test specimens or cleaned patches

Locations for specimen testing should include as wide as possible a range of conditions, and in particular

- any locations exhibiting evidence of some ULC in systematic patterns, eg above gaps, between boards
- uncorroded locations, to check that the environment is still inert
- in the centre of a bay and at the edge. Some samples (or cleaned areas) should be taken up into the area of the roll, particularly the inside where corrosion often occurs.
- over gaps and other weaknesses in the underlying decking

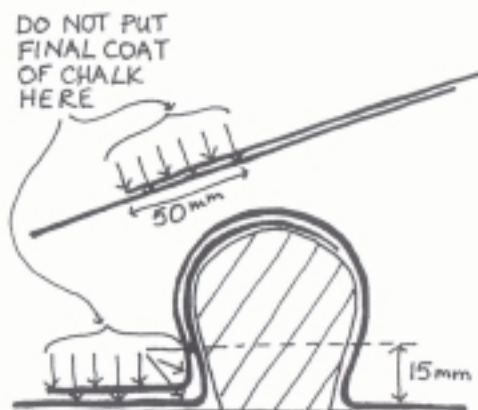
Figure 31 Do not put chalk at the very edges of the sheets. It could draw in moisture.

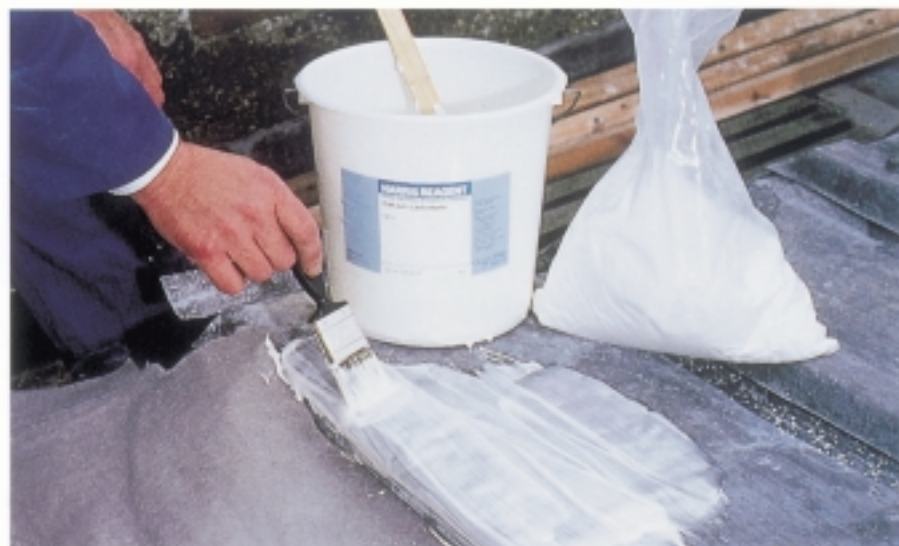
Figure 30 Applying the chalk slurry to the fresh lead. The coating thickness is sufficient when the surface of the lead can no longer be seen.
