ENGLISH HERITAGE

HERITAGE AT  
RISK  
REGISTER  
2013

SOUTH WEST

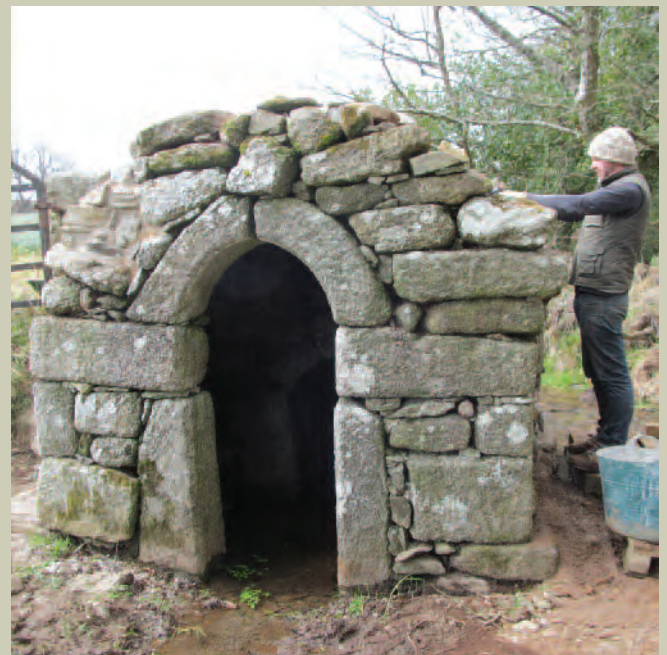
### TRELLILL HOLY WELL, HELSTON, CORNWALL

Extensive plant growth and water erosion were damaging this scheduled monument. A new owner, along with local volunteers, Cornwall's Monument Management Scheme and the local parish council, all contributed towards the repairs, resulting in this site being removed from the 2012 Heritage at Risk Register. Long term it will be maintained by this local partnership.

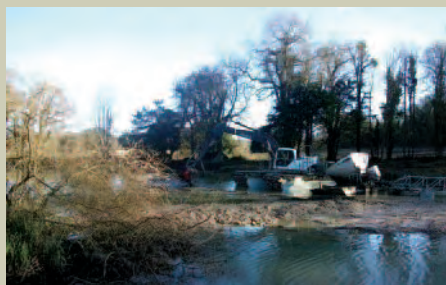
### ST GILES' HOUSE REGISTERED PARK AND GARDEN, DORSET

The grade II\* landscape at St Giles' House has been on the Heritage at Risk Register since 2009. It is still considered to be 'at risk', but with the energy and vision of the present Earl of Shaftesbury, and the commitment of Natural England's Higher Level Stewardship (HLS) scheme, its condition is rapidly improving.

A HLS agreement was signed between the St Giles' Estate and Natural England in 2011. With funding through HLS, a start has been made on a comprehensive programme of landscape conservation, restoration and enhancement. Projects already completed include de-silting the 18th century lake, as well as repairs to the Pepperpot Lodges and the Castellated Archway, and replanting of the Great Avenue. The HLS agreement will last for a period
