Heritage at **Risk**

Historic England

South East Register 2015

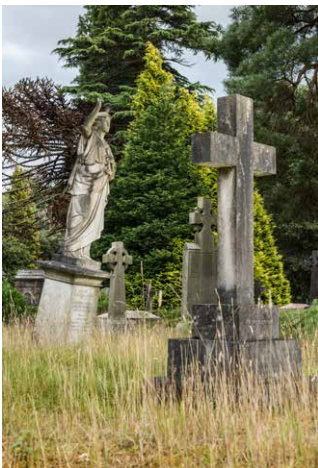
Brookwood Cemetery **Woking, Surrey**

Brookwood Cemetery is a Grade I registered park and garden (RPG). Although a burial ground, it was laid out as a park interspersed with buildings, and still has this character.

A long period of neglect and poor management was arrested by the previous owner, but there is still a backlog of repairs needed. The problems are compounded by vandalism and the failure of the ground drainage systems. Brookwood has been on the Heritage at Risk Register since 2009.

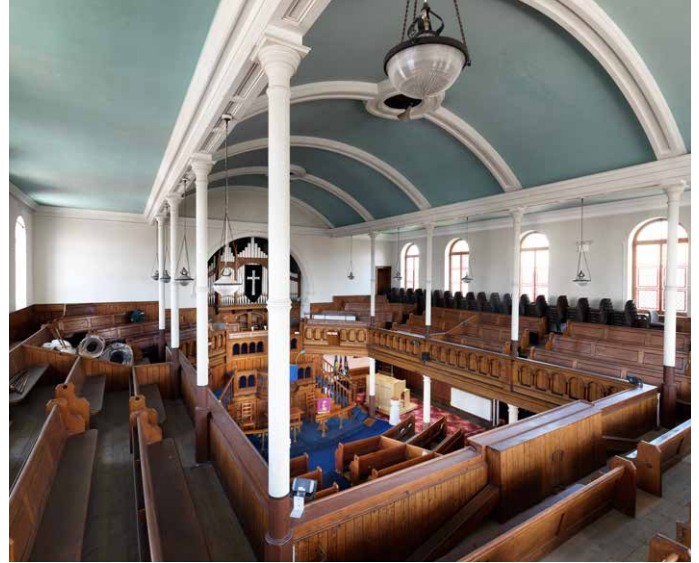
Trinity Methodist Church is a 1901 building designed by local architect and builder RJ Winnicott. It stands on the main thoroughfare of Albert Road, in central Southsea, the 19th century 'resort' suburb of Portsmouth. It was built to replace a smaller timber framed, corrugated iron structure, and the main worship space (seen right) has a very fine interior.

There have been problems with maintenance, and elements of the fabric coming to the end of their useful life. This has resulted in water penetration through the roofs and masonry at the southern end of the building, causing damage to internal finishes. It was added to the Heritage at Risk Register this year.

A Heritage Lottery Fund grant has allowed the congregation and their professional team to develop a project plan that will address the water penetration

problems and rectify the damage which has already occurred. This development work is now nearly complete. A successful second round grant application would see works begin on site by early 2016. This should result in the church's removal from the Heritage at Risk Register.
