Heritage at **Risk**

Historic England

South West Register 2016

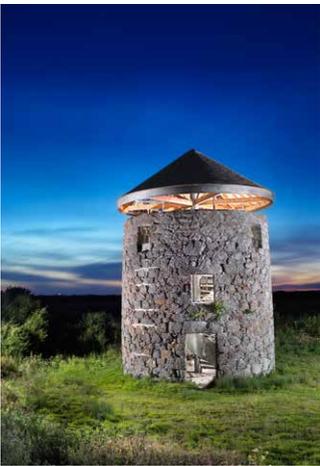
Old Windmill **Landwednack, Cornwall**

A very early tower mill, scheduled and listed grade II, which dates from the late 17th century. Originally for grinding grain, it was reused in the Second World War as a Home Guard observation platform. The windmill is a prominent and much-loved feature in the landscape, serving as a famous land and

The mill was added to the 2013 Heritage at Risk Register due to structural problems following removal of a temporary roof in the 1960s. The building was in an increasingly fragile state, requiring urgent repair and conservation. A significant concern was around the

Second World War opening on the west side of the tower, where timber supports had rotted away, leading to cracks and a loss of masonry. In addition, the earth mortar of the building had substantially eroded, leaving large voids, and the building was suffering movement following loss of the roof and floors.

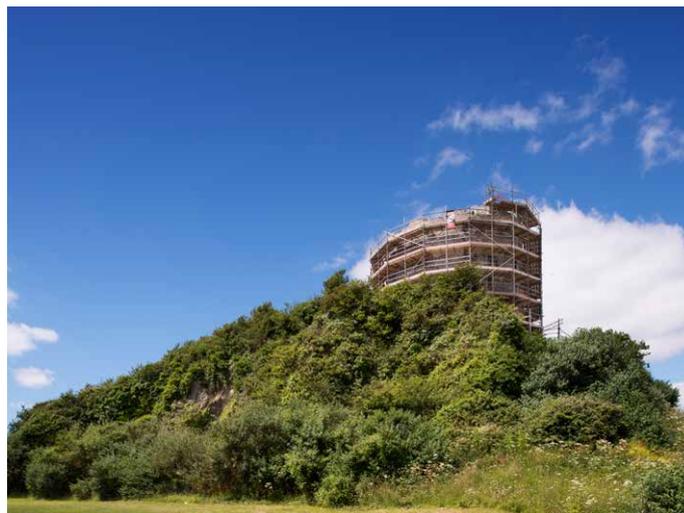
The tower is built of rubble with walls over three metres thick. Its entrance door is at first floor level, which helped protect it from attack. Up to eight guns were sited on the flat stone roof. Beneath this, the upper chamber has a stone vault supporting the roof, and a large fireplace. There is a smaller fireplace to the cellar. The interior is lit by small windows on the more protected north side.

Mount Batten Tower was added to the Heritage at Risk Register in 2015. Water was leaking through the walls, access was slippery, the oak lintels had rotted and there has been falls of stone internally. Historic England and Plymouth City Council have funded repairs during 2016.

The tower is now free of leaks and stonework and lintels are secure. It will be removed from the Heritage at Risk Register early next year.

Further money from the Coastal Revival Fund will provide a guard-rail around the parapets. Plans for a variety of new uses are underway.
