Heritage at **Risk**

Historic England

South West Register 2017

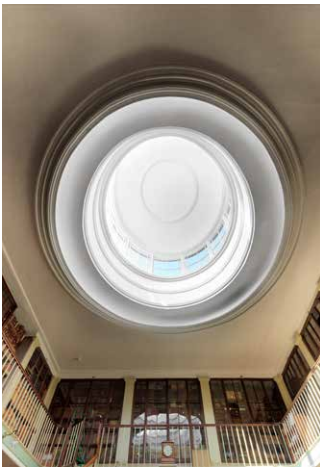
Devon and Exeter Institution **Exeter, Devon**

The Devon and Exeter Institution sits in the heart of Exeter in the Cathedral Close and is listed grade II*. Founded in 1813, the Institution took over the lease of its existing building in 1814 and altered an earlier medieval building to create a subscription library with two new galleried rooms with domed elliptical

lantern lights. The building still retains this layout.

In the winter of 2009, following heavy snowfall, cracks developed in the plasterwork of the domes. Conservation engineers found recent failure to the roof beams and that the previous attempts to strengthen the original undersized roof had not been that successful. Supporting internal safety scaffolds were immediately installed beneath both domes, removing all daylight, and the building was put on the Heritage at Risk Register.

This followed the completion of carefully planned and executed extensive roof repairs which were grant-aided by Historic England. The length of this project indicates its complexity and challenges. The domes of both lanterns and the main roofs have had new copper roofing installed, the structure supporting them has been carefully strengthened and the lantern windows and plasterwork repaired. This work has resulted in the building being removed from the Register.

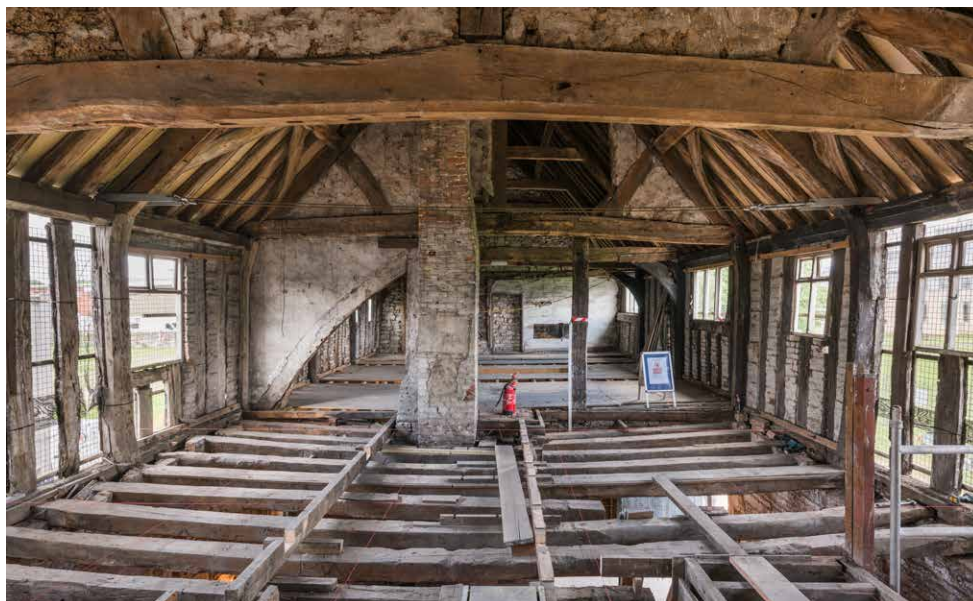
Llanthony Secunda Priory Gloucester

A large scheme to repair the vacant and derelict scheduled Llanthony Secunda Priory site is progressing thanks to grant aid from Historic England and Heritage Lottery Fund. Two vacant medieval buildings and the surrounding landscape are all being restored to create educational and assembly facility that will be used by the adjacent Gloucestershire College and by the wider community.

The Medieval Range building is a 15th century timber-framed building surviving from a longer Priory courtyard range. It has a close-studded upper floor on a lias stone ground floor. A Victorian farmhouse abuts one end. This will form a two storey facility with a large hall at first floor.

The second building is a late 15th century stables or guest range, notable for the earliest use of brick in this area. This is having a new modern roof and will form a single storey assembly space.
